Update "With-Site-Visit" Reserve Study

**Daniel Island POA
DICA
Daniel Island, SC**

**Report #: 15074-5
For Period Beginning: January 1, 2021
Expires: December 31, 2021**

Date Prepared: September 28, 2020

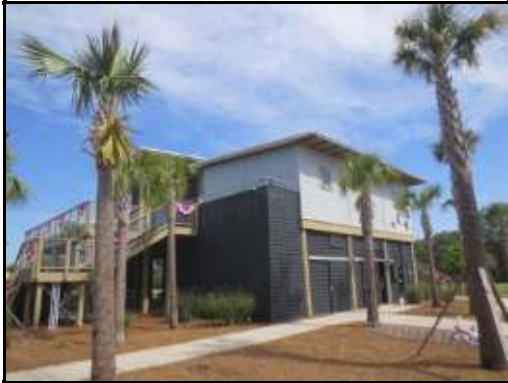
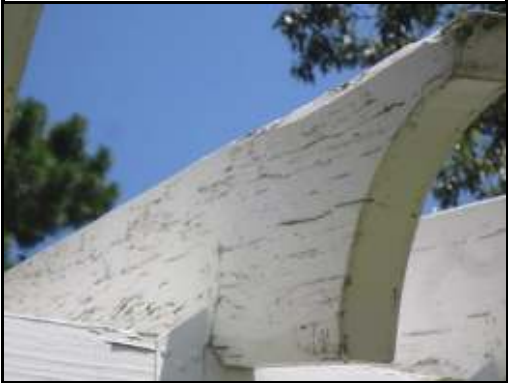
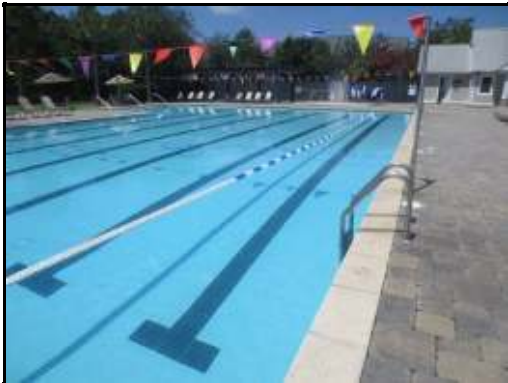
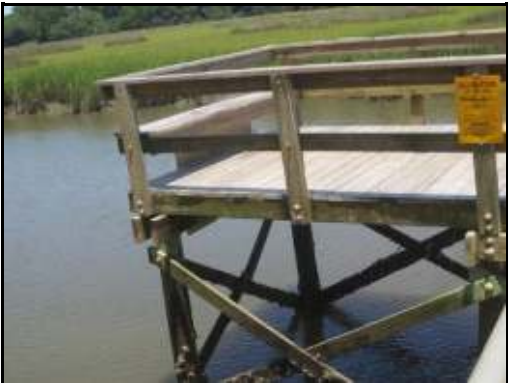
During our site visit on 6/30/2020, we visually inspected all the buildings and were able to see most components up close. The roofs were viewed from the ground but overall most appear to be aging normally. There was some surface wear noticed of the pergolas at each pool. They should be re-painted to help maintain the appearance that is common throughout the community.
