## Update "With-Site-Visit" Reserve Study

**Daniel Island POA  
DICA  
Daniel Island, SC**

**Report #: 15074-5  
For Period Beginning: January 1, 2021  
Expires: December 31, 2021**

**Date Prepared: September 28, 2020**

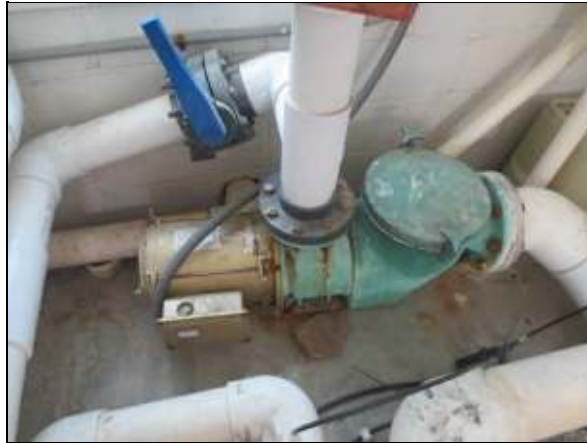
Pumps should be inspected regularly for leaks and other mechanical problems. Cost shown is based on replacement with the same type and size unless otherwise noted, and includes small allowance for new piping/valves/other repairs as needed. Minimal or no subjective/aesthetic value for pool and spa equipment. Useful life is based primarily on normal expectations for service/performance life in this location. Unless otherwise noted, remaining useful life expectancy is based primarily on original installation or last replacement/purchase date, our experience with similar systems/components, and assuming normal amount of usage and good preventive maintenance.

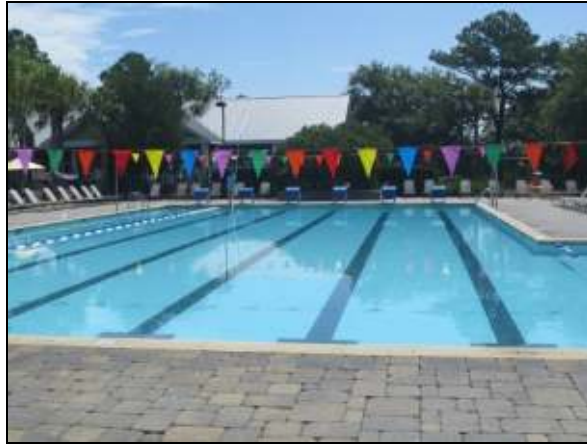
Comments: Pool footprint area is 83'x45' (main section) plus 30'x21' (warm up area). Depth ranges from 3' to 5'. Pool resurfacing will restore the aesthetic quality of the pool while protecting the actual concrete shell of the pool from deterioration. While drained for resurfacing, any other repairs to lighting, handrails, stairs, ladders, etc. should be conducted as needed. This type of project is best suited for slow/offseason to minimize downtime during periods when pool is used heavily. Should be expected at the approximate interval shown below to preserve this important amenity of the association.

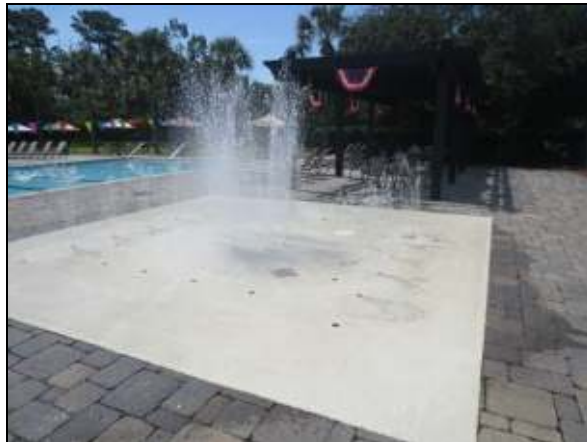
Comments: Splash pad is a concrete area with (38) in-ground jets/fountains. Not in use at time of inspection but assumed to be functional. A general allowance for repairs and maintenance is shown here. Best practice would be to coordinate projects with resurfacing projects for pool to minimize unnecessary downtime.

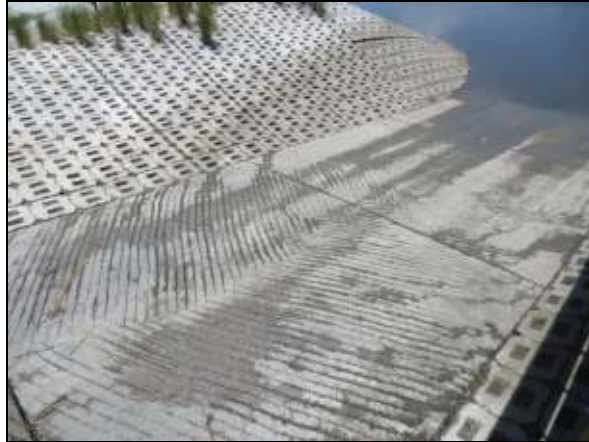
Comments: Some breakage in isolated sections. No consistent deterioration issues noticed.

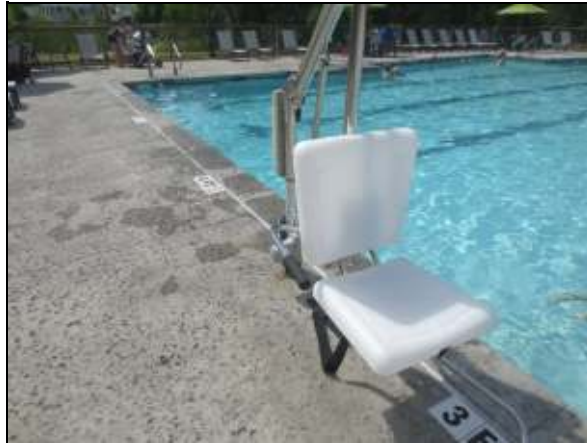
ADA lifts should be inspected regularly to ensure proper function and safe conditions. Make minor repairs and replace individual parts as needed as an Operating expense. Plan for upgrade or replacement at the approximate interval shown here. Minimal or no subjective/aesthetic value for pool and spa equipment. Useful life is based primarily on normal expectations for service/performance life in this location. Unless otherwise noted, remaining useful life expectancy is based primarily on original installation or last replacement/purchase date, our experience with similar systems/components, and assuming normal amount of usage and good preventive maintenance.

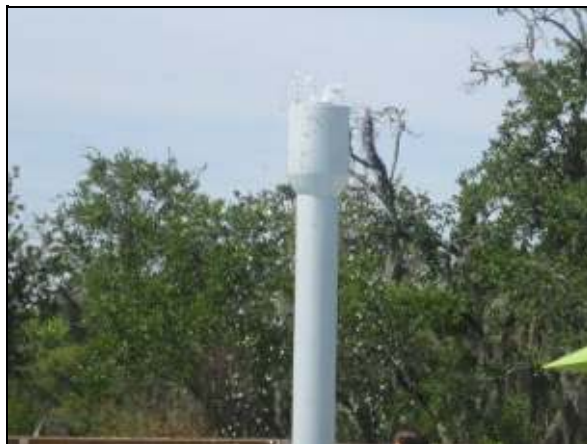
Comments: Functioning properly during the site visit. Full replacement expected in the future.
