**Daniel Island POA
DIPA
*Daniel Island, SC***

Report #: 15074-6
Beginning: February 1, 2024
Expires: December 31, 2024

**RESERVE STUDY
Update "With-Site-Visit"**

September 11, 2023

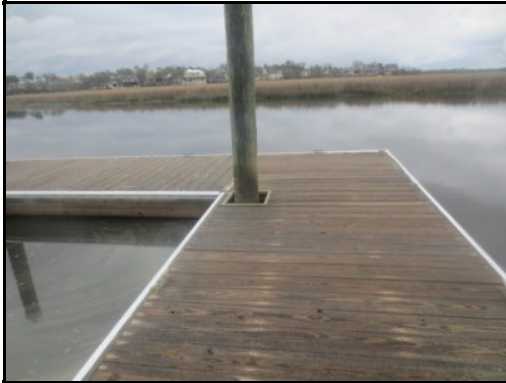
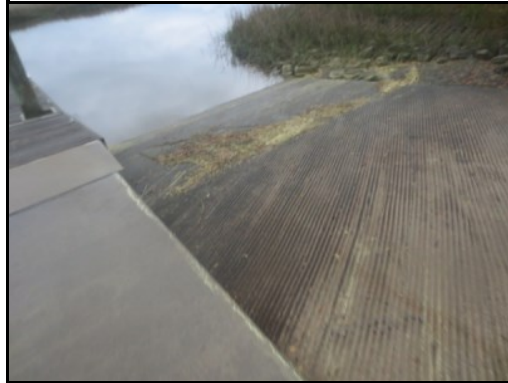
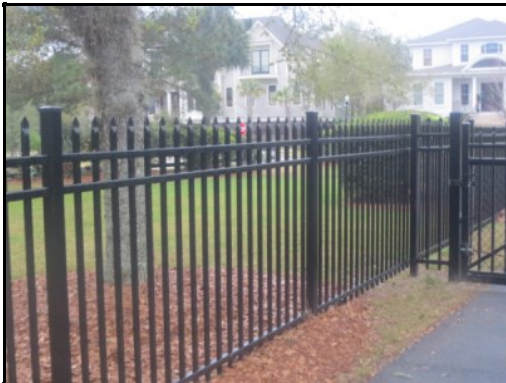
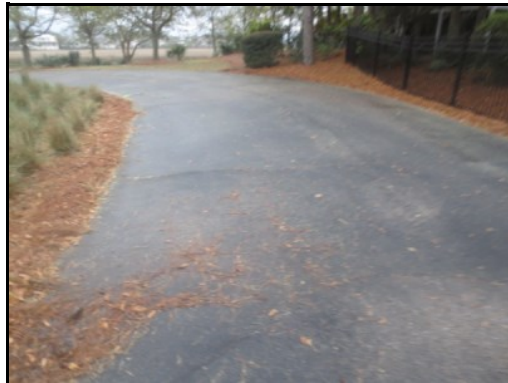
During our site visit on 7/21/2023, we met with the Maintenance team to discuss the property changes since our last visit. The dock area looked clean and some minor repairs were noticed. The boat ramp was free from any consistent breaking or major damage. No major issues were noticed at this time of our visit.

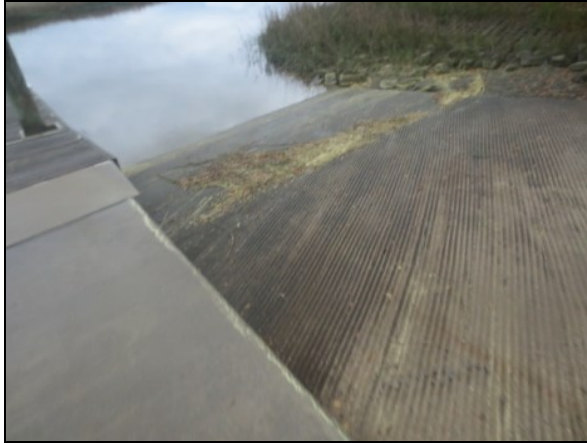
Comp #: 2101 Concrete Boat Ramp - Replace**Quantity: Apprx 1,500 GSF**

Comments: Concrete boat ramp should have an indefinitely long useful life with no predictable need for complete replacement. Based on National Reserve Study Standards, the life expectancy is likely too unpredictable for Reserve funding. Make repairs as needed as an Operating expense. If a pattern of larger repair needs develops over time, an allowance may be added to the Reserve Study as needed.

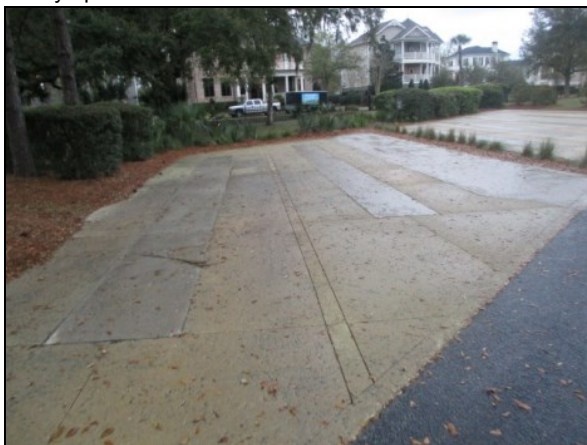
Comp #: 2105 Concrete Boat Trailer Pkng - Repair**Quantity: Apprx 5,440 GSF**

Comments: Concrete driveways determined to be in fair condition typically may exhibit small changes in slope and narrow "hair-line" wide cracks. Overall, no unusual or extreme signs of age noted. Driveways are reported to be the maintenance and repair responsibility of the Association. Although complete replacement of all areas together should not be required, conditions observed merit inclusion of an allowance for ongoing repairs and partial replacements. Timeline and cost ranges shown here should be re-evaluated during future Reserve Study updates.

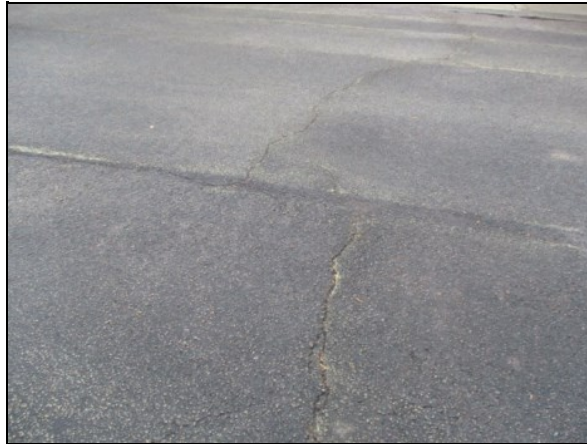
Comp #: 2123 Asphalt - Seal/Repair

Comments: Some cracking was noticed but there was no major breakage at the time of the site visit. Regular cycles of seal coating (along with any needed repair) has proven to be the best program in our opinion for the long term care of lower traffic asphalt areas such as these. The primary reason to seal coat asphalt pavement is to protect the pavement from the deteriorating effects of sun and water. When asphalt pavement is exposed, the asphalt oxidizes, or hardens which causes the pavement to become more brittle. As a result, the pavement will be more likely to crack because it is unable to bend and flex when subjected to traffic and temperature changes. A seal coat combats this situation by providing a water-resistant membrane, which not only slows down the oxidation process but also helps the pavement to shed water, preventing it from entering the base material. Seal coat also provides uniform appearance, concealing the inevitable patching and repairs which accumulate over time. Seal coat ultimately extends useful life of asphalt, postponing the asphalt resurfacing, which can be one of the larger cost items in this study (see component #2125 for asphalt resurfacing costs). Repair asphalt before seal coating. Surface preparation and dry weather, during and following application, is key to lasting performance. The ideal conditions are a warm, sunny day with low humidity; rain can cause major problems when seal coating and should never be done when showers are threatening. Incorporate any striping and curb repair into this project. Fill cracks and clean oil stains promptly in between cycles as routine maintenance.

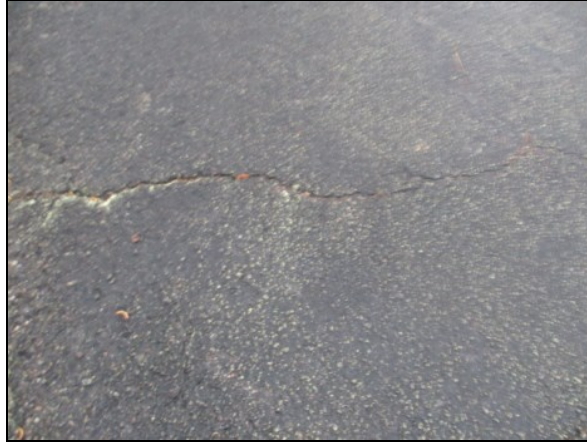
Comments: It was reported that this will be resurfaces in 2023. We recommend having surface sealed and repaired as directed in component #2123; regular cycles of seal coating are recommended for maximum design life. As routine maintenance, keep roadway clean, free of debris and well drained; fill/seal cracks to prevent water from penetrating into the sub-base and accelerating damage. Even with ordinary care and maintenance, plan for eventual large scale resurface (milling and overlay) at roughly the time frame below. As timing draws nearer, consult with asphalt vendor/consultant for recommendations and complete scope.

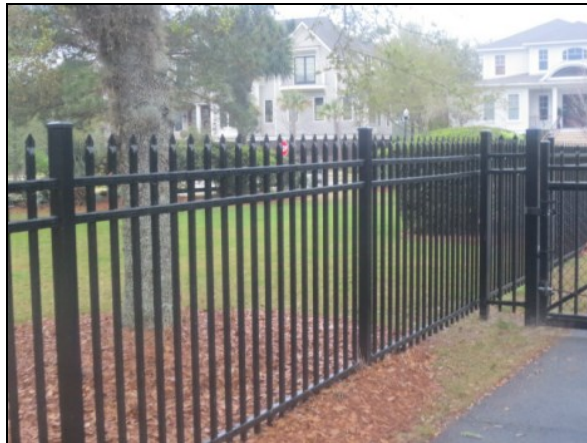
Comp #: 2137 Metal Fence - Replace**Quantity: Numerous LF**

Comments: Metal fencing determined to be in good physical/structural condition is stable and upright, with no signs or reports of damage or required repairs. All components and hardware appear to be in serviceable condition with no unusual or advanced signs of wear or age. The fencing is in good aesthetic condition. In our experience, metal fencing will typically eventually break down due to a combination of sun and weather exposure, which is sometimes exacerbated by other factors such as irrigation overspray, abuse, and lack of preventive maintenance. For some types of fencing, complete replacement is advisable over recoating or refinishing due to the relatively short lifespan of coatings and consideration of total life-cycle cost.

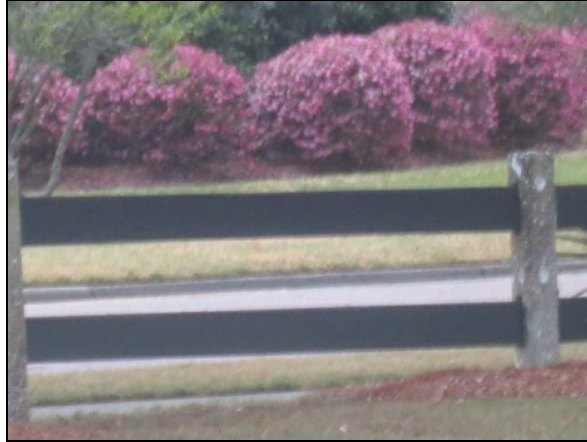
Comp #: 2139 Site Fencing: Wood - Replace**Quantity: Approx 640 LF Fence**

Comments: Overall still aging normally. 2-rail split fences. Some chips and scratches, but no severe wear or age noted. As routine maintenance, inspect regularly for any damage, repair as needed and avoid contact with ground and surrounding vegetation wherever possible. Regular cycles of uniform, professional sealing/painting will help to maintain appearance and maximize life. Plan to replace at roughly the time frame below with funding included here for similar wood replacement. At next replacement, association might want to consider replacing with more sturdy, lower-maintenance products like composite, vinyl, etc. Although installation costs are higher, total life cycle cost is lower due to less maintenance and longer design life expectancy.

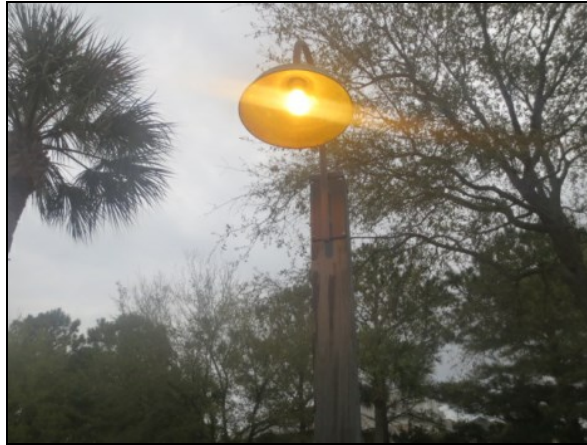
Comp #: 2175 Parking Lot Lights - Replace**Quantity: (3) Pole Lights**

Comments: Decorative fixtures on 6"x6" wood posts. Observed during daylight hours; assumed to be in functional operating condition. As routine maintenance, inspect, repair/change bulbs as needed. Best to plan for large scale replacement at roughly the time frame below for cost efficiency and consistent quality/appearance throughout association.

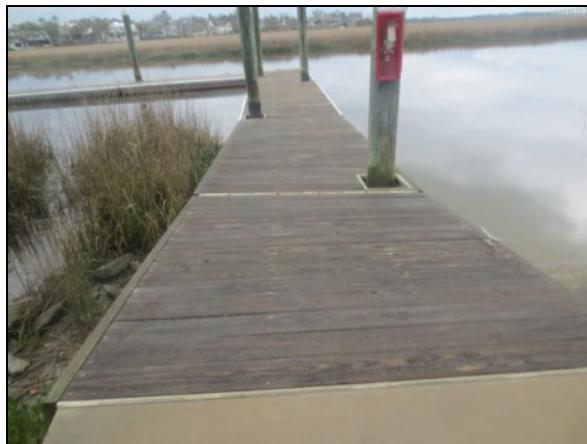
Comments: Dock structures determined to be in fair condition typically exhibit more moderate signs of exposure and wear to structural elements. Structure should be mostly level and stable, but at this stage, more exposed components may begin to wear at an accelerated pace. Still generally sturdy, but likely to require more frequent repairs and maintenance. Assuming normal wear and tear and good preventive maintenance, complete replacement or reconstruction may be required at longer intervals, including some or all components of the structural framework, pilings, etc. Our inspection is visual only and limited to accessible areas, and does not incorporate any specific testing or thorough structural evaluation. Life and cost estimates shown here are intended for planning and budgeting purposes and may need to be re-evaluated in light of any more thorough analysis or other outside information.

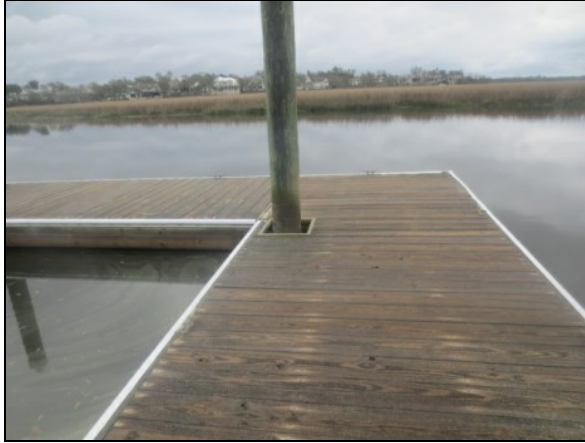
Comp #: 2193 Boat Dock (Structure) - Replace

Comments: The overall structure comprised of (7) attached sections of floating docks, with (7) wood pilings. Please refer to the previous component #2192 for more information on the conditions of the structure.

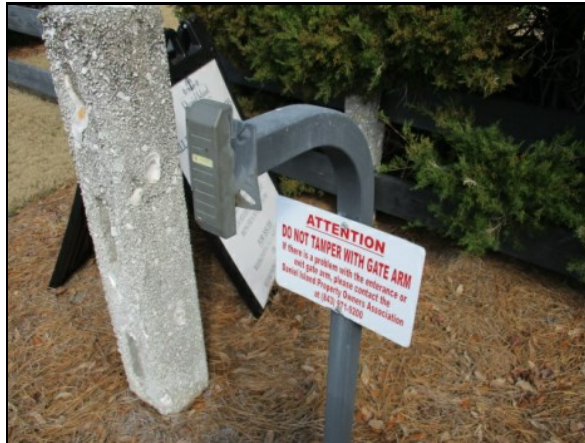
Comp #: 2501 Card Reader - Replace

Comments: There are no barrier arms so assumed to not be replaced in the future. One card reader, which appeared to be original to this area. Worn and weathered appearance. Not tested, but assumed to be functional. Cost to replace one card reader is not expected to meet threshold for Reserve funding. Replace as needed as an Operating expense, or in conjunction with the barrier arm units.

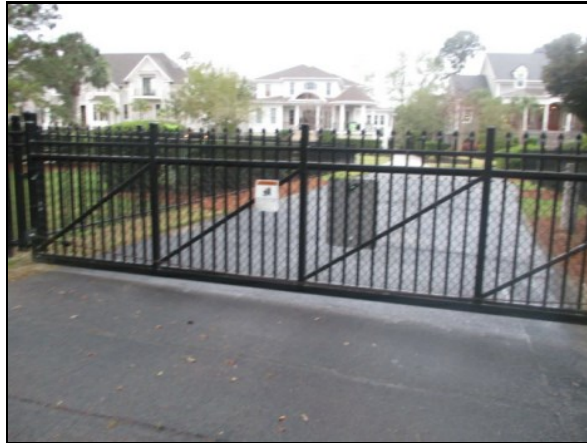
Comp #: 2511 Sliding Gate - Replace**Quantity: (2) Gates**

Funding recommendation is primarily for the motor/mechanical unit, not the gate itself, which is generally replaced as an Operating/maintenance expense as needed. Life expectancy can vary based on level of use, exposure to the elements, level of preventive maintenance, etc. Should be inspected and repaired as needed by servicing vendor to attain full life expectancy. Minimal or no subjective/aesthetic value for this component. Useful life is based primarily on normal expectations for service/performance life in this location. Unless otherwise noted, remaining useful life expectancy is based primarily on original installation or last replacement/purchase date, our experience with similar systems/components, and assuming normal amount of usage and good preventive maintenance.
