**Daniel Island POA**  
**Captains Island**  
***Daniel Island, SC***

Report #: 45322-0  
Beginning: January 1, 2026  
Expires: December 31, 2026

**RESERVE STUDY**  
**Update "With-Site-Visit"**

June 23, 2025

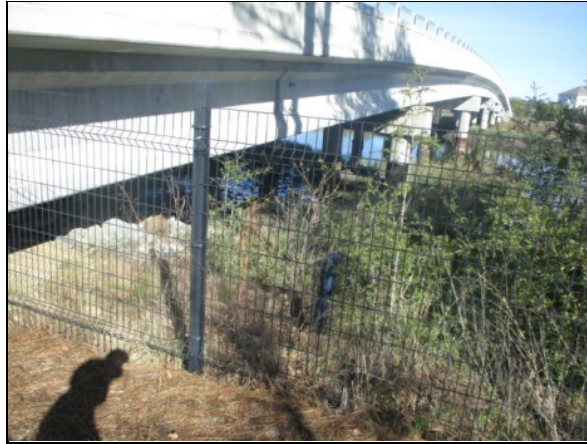
In our experience, metal fencing will typically eventually break down due to a combination of sun and weather exposure, which is sometimes exacerbated by other factors such as irrigation overspray, abuse and lack of preventive maintenance. For some types of fencing, complete replacement is advisable over minor repairs paired with recoating or refinishing due to relatively short lifespan of coatings and consideration of total life-cycle cost. Based on evident conditions at the time of inspection, plan to replace at the approximate interval below. Remaining useful life of the fencing may be prolonged through painting/re-coating, so this component should be re-evaluated during future Reserve Study updates based on the most current conditions and information available at that time. Cost estimate range below assumes replacement with similar quantity, material, and style as existing fencing.

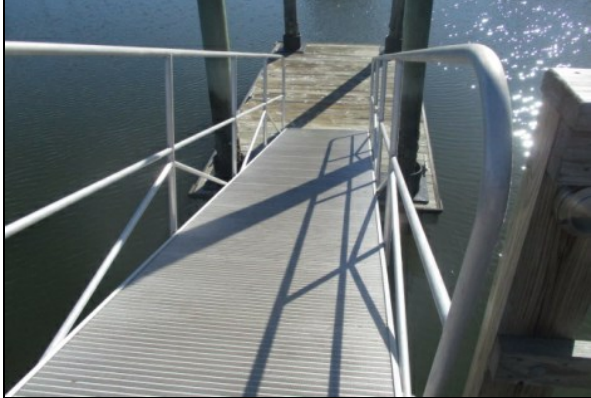
**Approx Quantity:** 210 GSF

Floating dock should be inspected regularly for safety concerns (i.e. trip hazards, loose attachments, etc.). Minor repairs and individual replacements are expected to be handled as an Operating expense. Useful life can vary greatly depending on level of wave exposure, tidal swings, weather, aesthetic standards, etc. Based on current conditions evident and historical information provided, we recommend that the Client plan to replace the entire assembly at the approximate interval shown below. Unless otherwise noted, cost estimates below are based on replacement with a similar type currently in place.

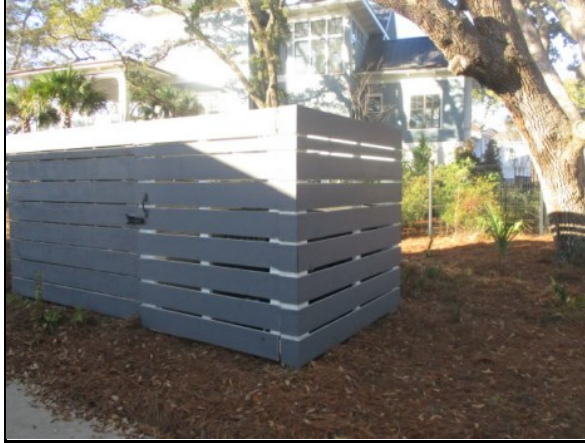
**Comments:** Trash enclosures should be cleaned and inspected regularly, and repaired as needed to ensure safety and good function. Enclosures left to deteriorate can become an eyesore and will have a negative effect on the aesthetic value in the common areas. Cost estimates related to this component are not expected to meet the minimum threshold for Reserve funding at this time. As such, costs related to this component are expected to be included in the Client's Operating budget. However, any repair and maintenance or other related expenditures should be tracked, and this component should be re-evaluated during future Reserve Study updates based on most recent information and data available. If deemed appropriate for Reserve funding, component can be included in the funding plan at that time.

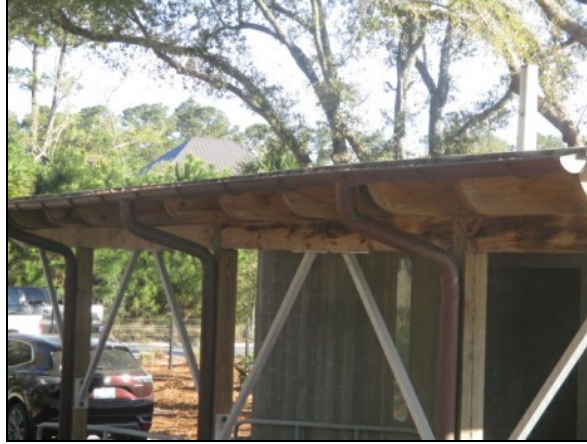
**Comments:** Cost estimates related to this component are not expected to meet the minimum threshold for Reserve funding. As such, costs related to this component are expected to be included in the Client's Operating budget. However, any repair and maintenance or other related expenditures should be tracked, and this component should be re-evaluated during future Reserve Study updates based on most recent information and data available. If deemed appropriate for Reserve funding, component can be included in the funding plan at that time.

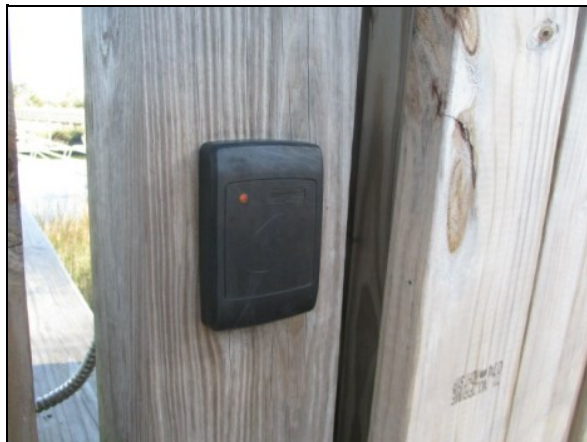
**Comments:** Card/fob reader devices are assumed to be functional. Minimal or no subjective/aesthetic value for this component. Individual readers can often be replaced as an Operating expense due to damage or localized failures. Due to use, exposure, and advancements in technology, we recommend to plan for replacement of devices and control system at the approximate interval shown below. To ensure a functional, compatible system and obtain better pricing, plan on replacing all devices together as one project. Any partial repair and/or replacement expenditures should be tracked, and this component should be re-evaluated during future Reserve Study updates based on most recent information and data available.

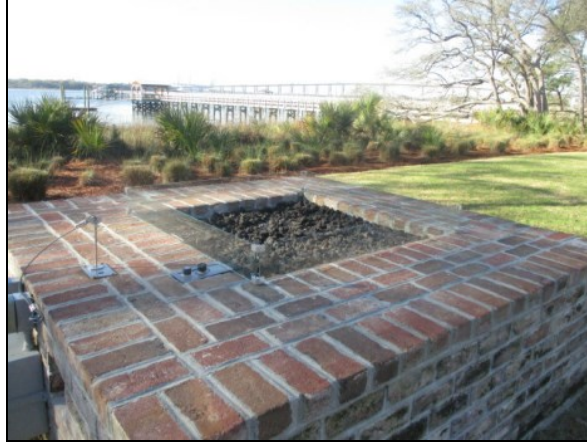
**Comments:** Life expectancy and/or potential cost estimates related to this component are deemed to be too indeterminate for Reserve funding at this time. However, any significant expenditures related to this component (other than routine maintenance) should be tracked/reported by the Client. This component should then be re-evaluated during future Reserve Study updates based on most recent information and data available at that time. If deemed appropriate for Reserve funding, component can be included in the funding plan at that time.
