**Daniel Island POA**  
**DIPA**  
***Daniel Island, SC***

Report #: 45321-8  
Beginning: January 1, 2026  
Expires: December 31, 2026

**RESERVE STUDY**  
**Update "With-Site-Visit"**

June 23, 2025

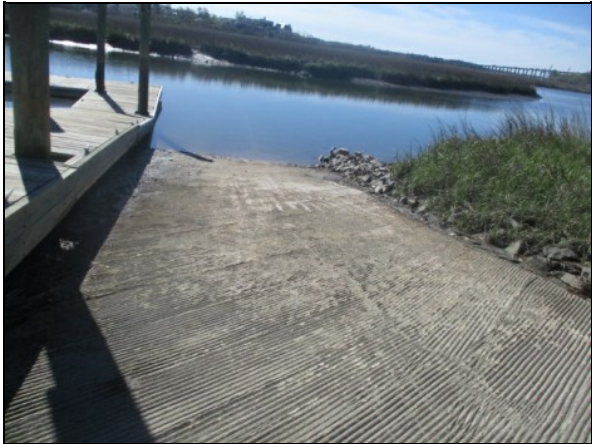
**Useful Life:**  
25 years

**Remaining Life:**  
24 years

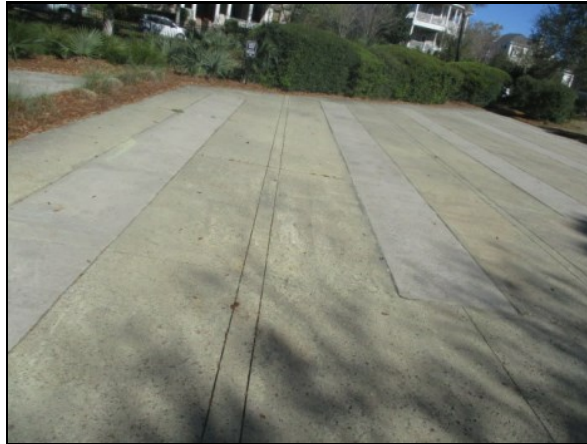
**Remaining Life:**

3 years

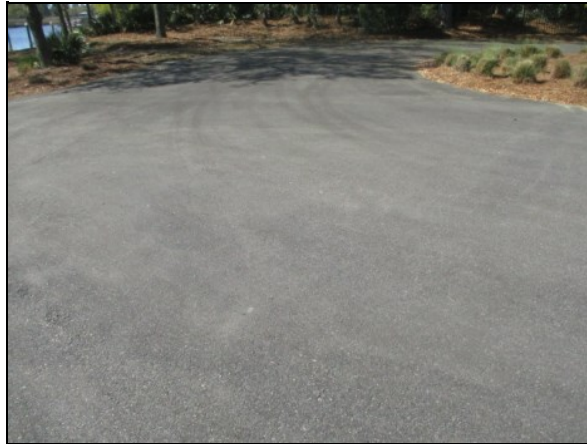
**Remaining Life:**

2 years

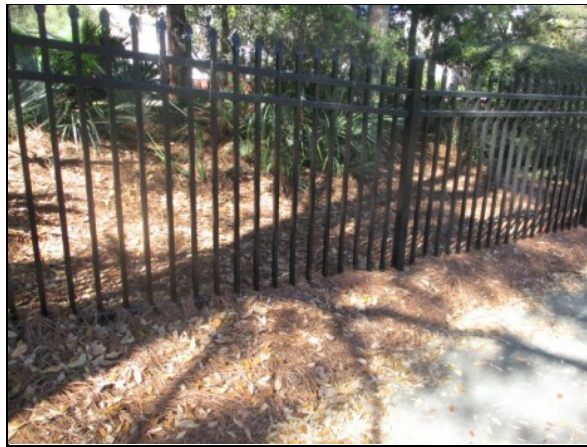
**Remaining Life:**

25 years

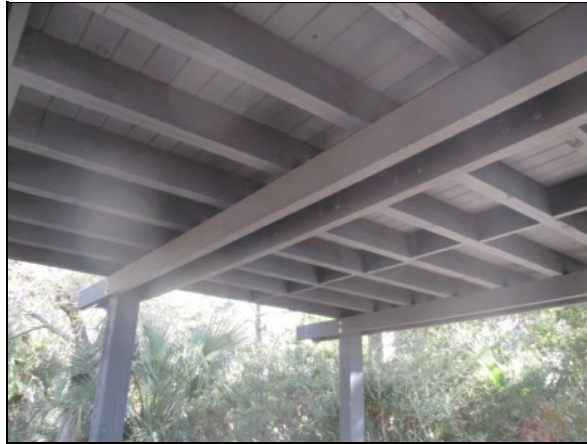
**Remaining Life:**

17 years

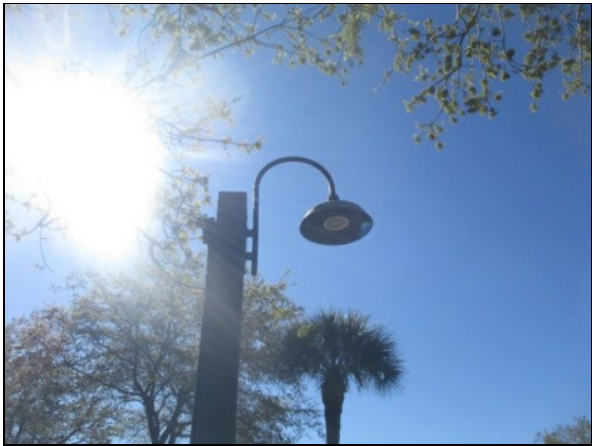
**Useful Life:**  
20 years

**Remaining Life:**  
0 years

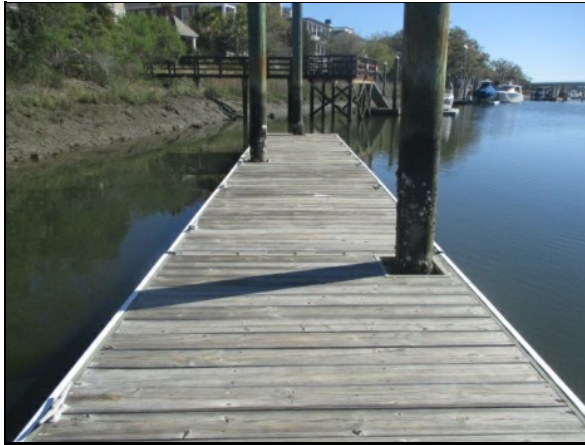
**Remaining Life:**

14 years

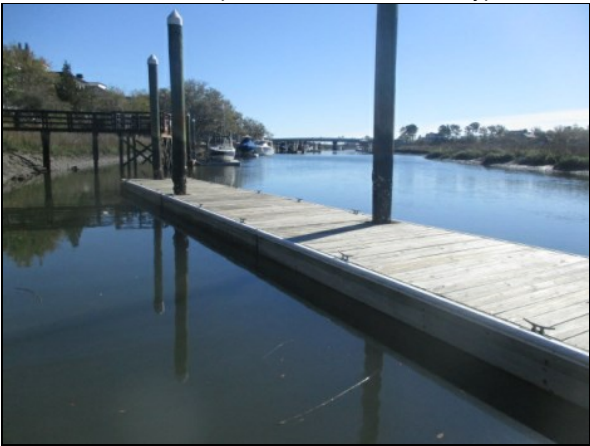
**Useful Life:**  
30 years

**Remaining Life:**  
29 years

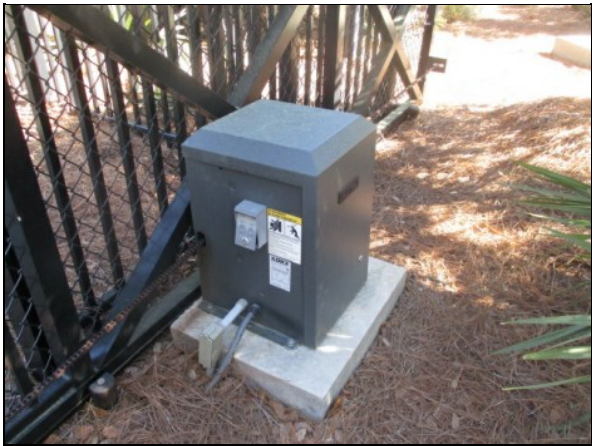
**Useful Life:**  
15 years

**Remaining Life:**  
4 years

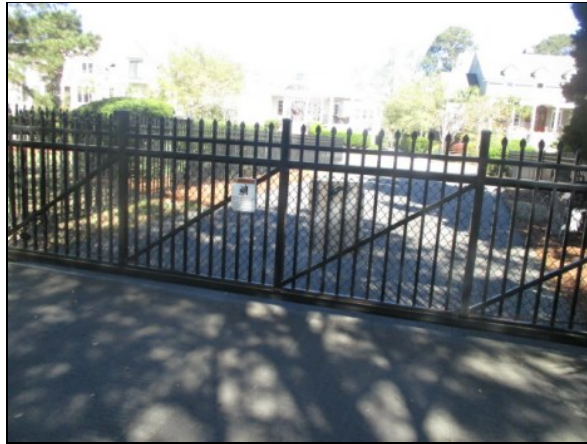
**Remaining Life:**

20 years

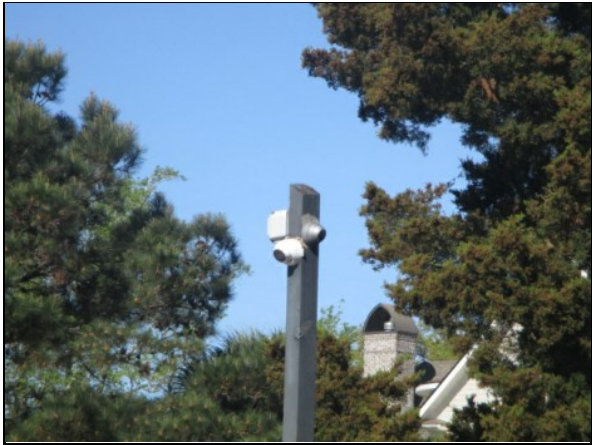
**Remaining Life:**

9 years

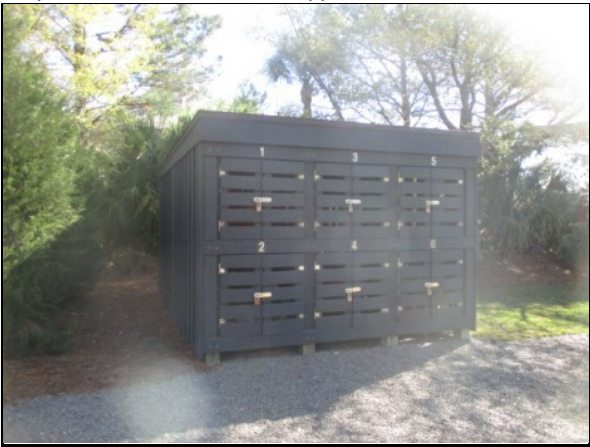
**Useful Life:**  
20 years

**Remaining Life:**  
14 years

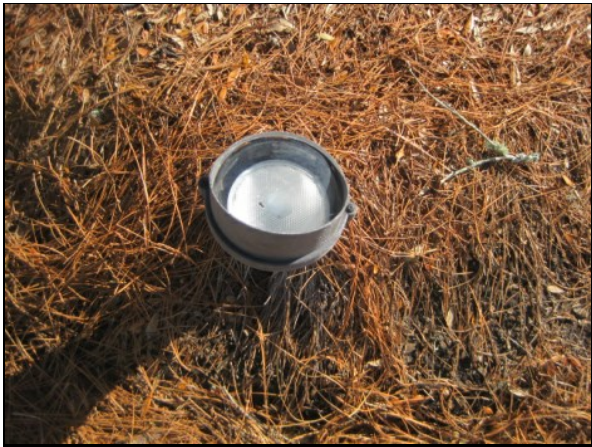
**Useful Life:**  
5 years

**Remaining Life:**  
0 years

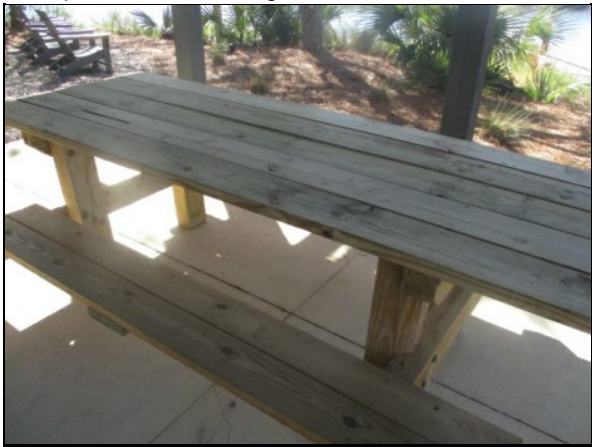
**Useful Life:**  
15 years

**Remaining Life:**  
4 years

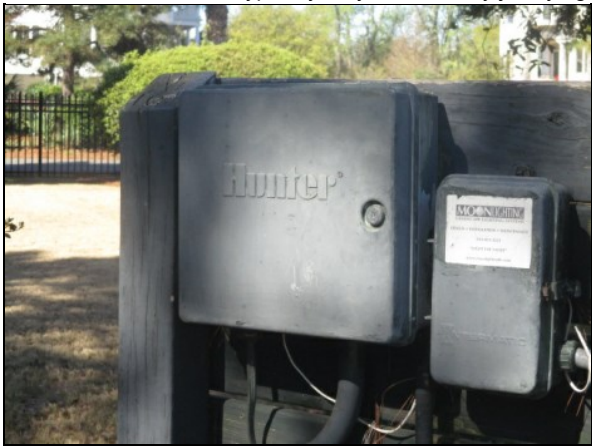
**Useful Life:**  
15 years

**Remaining Life:**  
2 years
