## The Retreat *Daniel Island, SC*

Report #: 53359-0  
Beginning: January 1, 2026  
Expires: December 31, 2026

# RESERVE STUDY "Full"

June 23, 2025

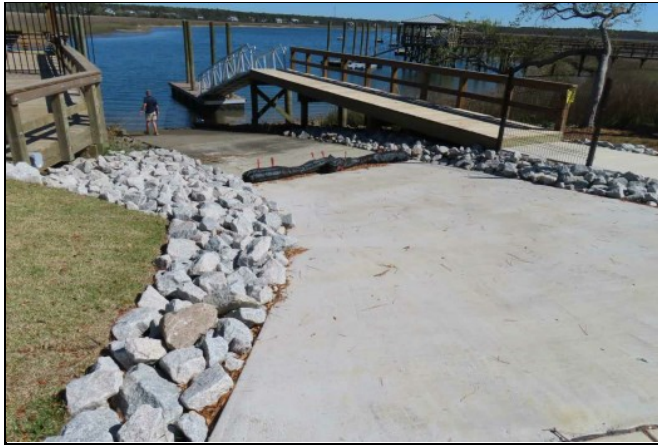
Boat launch are reported to be the maintenance, repair, and replacement responsibility of the Client. All areas should be inspected periodically to identify potential trip hazards or other safety issues. Concrete maintenance typically consists of pressure washing, crack repairs, and replacement of small sections as-needed. Exposure to sunlight, weather, and frequent vehicle traffic can lead to larger, more frequent repairs, especially for older properties. Due to evident conditions at the time of inspection, comprehensive replacement is anticipated at the approximate timeframe below. However, we recommend that the Client consult with a qualified professional (consultant, contractor, or engineer) to determine potential replacement timelines and cost estimates. This component should then be re-evaluated during future Reserve Study updates and adjustments made based on the most current information available at that time.

**Useful Life:**  
40 years**Remaining Life:**  
38 years

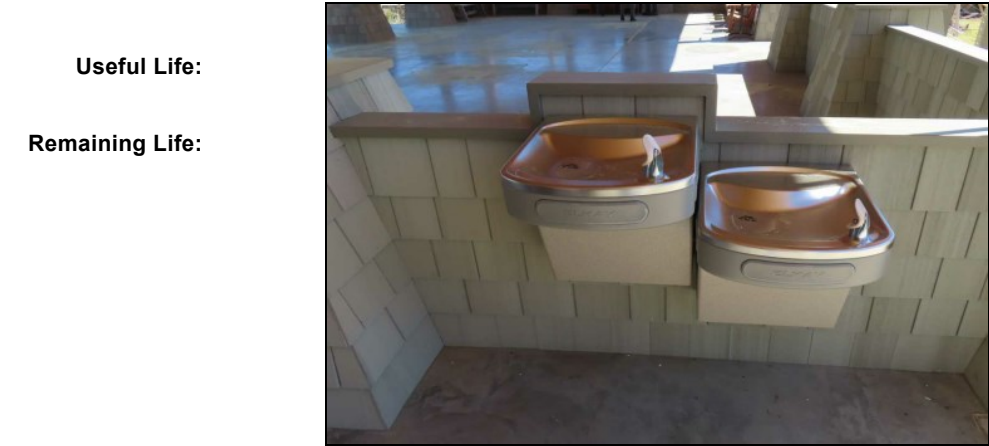
**History:** Presumed to be original to the construction of the community (2024)

**Comments:** Cost estimates related to this component are not expected to meet the minimum threshold for Reserve funding. As such, costs related to this component are expected to be included in the Client’s Operating budget. However, any repair and maintenance or other related expenditures should be tracked, and this component should be re-evaluated during future Reserve Study updates based on most recent information and data available. If deemed appropriate for Reserve funding, component can be included in the funding plan at that time.
