Update "With-Site-Visit" Reserve Study

**Daniel Island POA
DICA
Daniel Island, SC**

**Report #: 15074-5
For Period Beginning: January 1, 2021
Expires: December 31, 2021**

Date Prepared: September 28, 2020

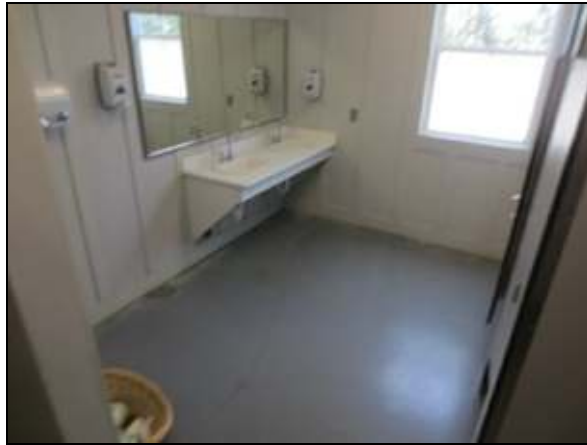
Comments: Bathrooms are in fair condition. RUL has been slightly extended. Men's has (2) sinks, (2) urinals, (1) toilet and (1) shower. Women's is about the same but with (2) toilets. Concrete floors and plain fixtures and finishes.

Fair condition: Bathrooms determined to be in fair condition typically exhibit some light to moderate signs of use and age. Finishes are clean but showing some wear. All fixtures are assumed to be functional, but may be becoming outdated at this stage. Generally in serviceable condition.

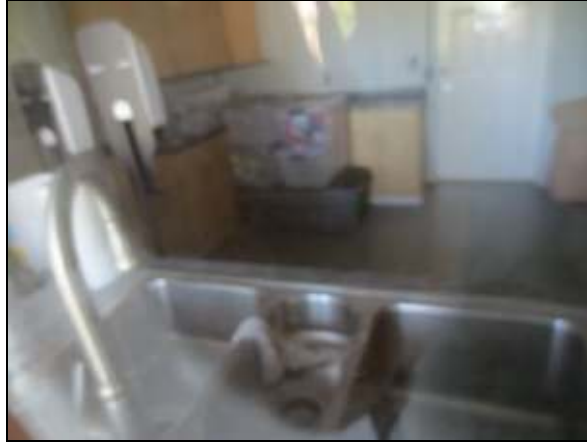
Comp #: 2749 Kitchen Appliances - Replace

Comments: Appliances were not tested but assumed to be functioning normally. Equipment had included a microwave, refrigerator/freezer combo and a humidifier. Individual appliances were not tested during inspection, and are assumed to be in functional operating condition unless otherwise noted. Replacement should ideally be coordinated with kitchen remodeling (see component #2747). Funding recommendation shown here is for replacing with comparable quality appliances. Individual pieces may be replaced as needed using Operating funds.

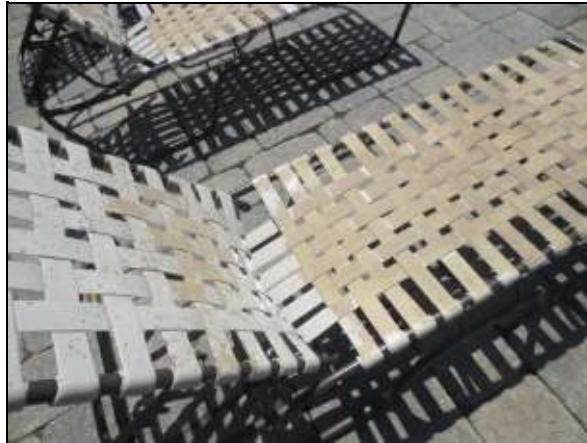
Comp #: 2763 Pool Deck Furniture - Replace

Comments: (53) lounges, (14) tables, (67) chairs, (2) benches, (2) trash cans were counted during the inspection. Umbrellas may have been in storage for the season. RUL has been truncated as many of the lounges appear to be aging poorly and have significant surface wear. Could be restrapped.

Inspect regularly and repair or replace any damaged pieces promptly to ensure safety. Protected storage of furniture when not in use can help to extend useful life. Best practice is to replace all pieces together in order to maintain consistent style and quality in the pool/recreation area. Costs can vary greatly based on type of pieces selected for replacement. Funding recommendation shown here is based on replacement with comparable quality pieces.

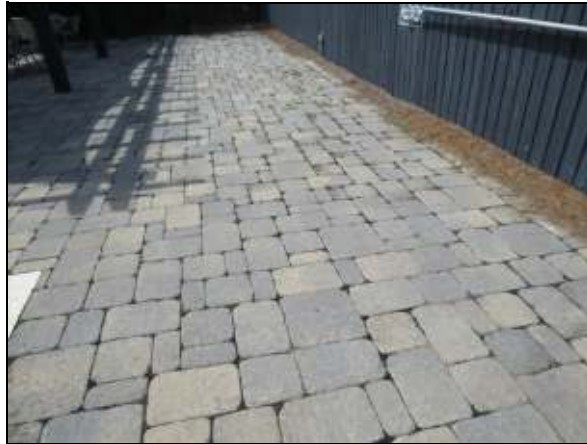
Comments: Good condition: Paver pool decks determined to be in good condition typically exhibit an even and positively sloped surface. No obvious trip hazards or significant cracking or damage. Good aesthetic appeal.

Paver decks should have a long useful life under normal circumstances. Should be pressure-washed as needed to preserve appearance and remove stains, chemical residue, etc. Replacement costs can vary depending on style of pavers chosen, configuration of deck, etc. We recommend budgeting for replacement at the approximate interval shown here.

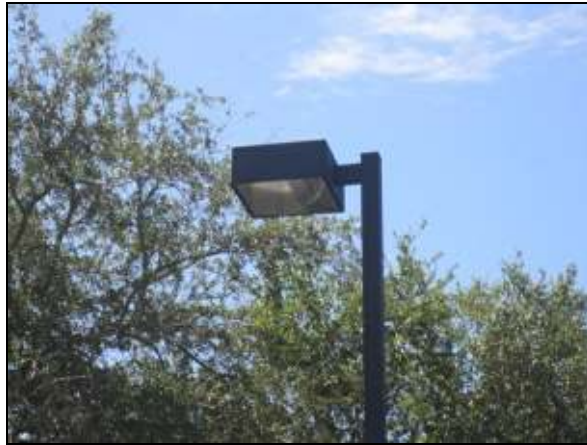
Comp #: 2772 Pool Deck Lights - Replace

Comments: (7) single-fixtures, and (3) dual fixtures (as pictured). Fair condition: Pool deck lights determined to be in fair condition typically exhibit somewhat faded/worn appearance but overall assembly is sturdy and aging normally. Serviceable physical condition and still appropriate for aesthetic standards.

Lighting around the pool deck should be inspected regularly to ensure adequate brightness at night for safety. Replacement is often coordinated with other exterior or site lighting, or with pool fence or other components in this area. Cost shown are based on replacement with comparable size and design standards.

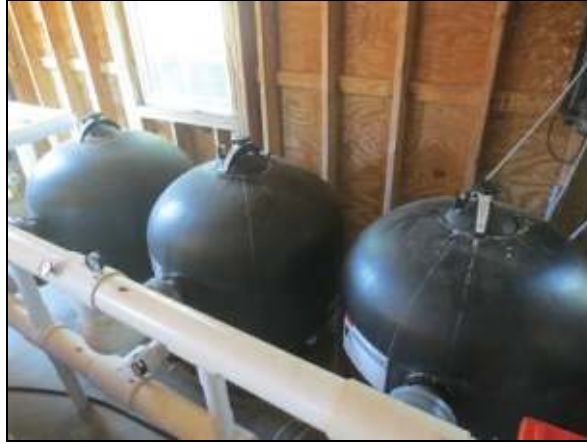
Comp #: 2779 Pool Filters - Replace

Comments: (3) Triton II Commercial TR-140C filters, and (1) Triton II AT-60 for the spray pad. All are in a protected area and appear to be the original ones. Pool vendor should inspect regularly for optimal performance and address any repairs or preventive maintenance as needed. Life can vary depending on location, as well as level of use and preventive maintenance. In most cases, replacement cost does not meet threshold for Reserve funding. Replace as needed within annual Operating budget.

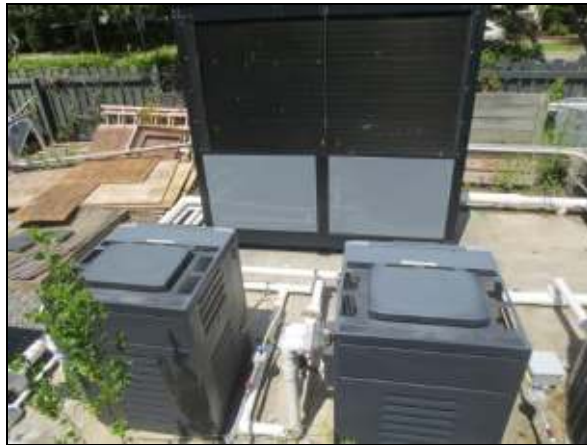
Comp #: 2781 Pool Heaters - Replace

History: Replaced in 2018; total cost reported to be \$44,889

Pool vendor should inspect heater regularly to ensure proper function, identify any required repairs, etc. Internal components were not analyzed during our site inspection. Many clients choose not to heat their pools year-round, which can prolong the life of the heater while reducing energy costs. When replacement models are being evaluated, we recommend considering high efficiency models which may have a higher initial cost but will ultimately be less expensive due to reduced energy usage. Minimal or no subjective/aesthetic value for pool and spa equipment. Useful life is based primarily on normal expectations for service/performance life in this location. Unless otherwise noted, remaining useful life expectancy is based primarily on original installation or last replacement/purchase date, our experience with similar systems/components, and assuming normal amount of usage and good preventive maintenance.

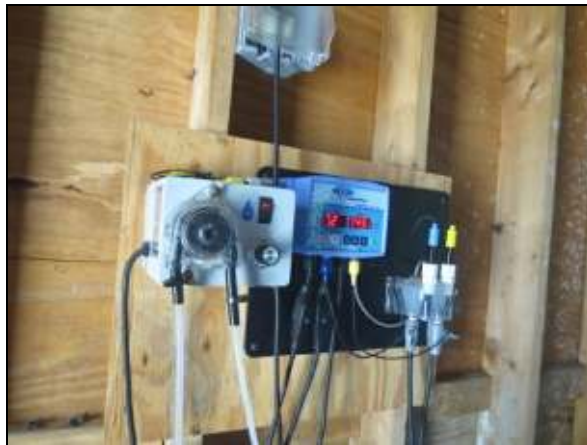
Comp #: 2789 Chlorination Systems - Replace

Comments: No access to inspect at time of 2018 inspection date. Assumed to be same equipment as observed during 2014 inspection date.

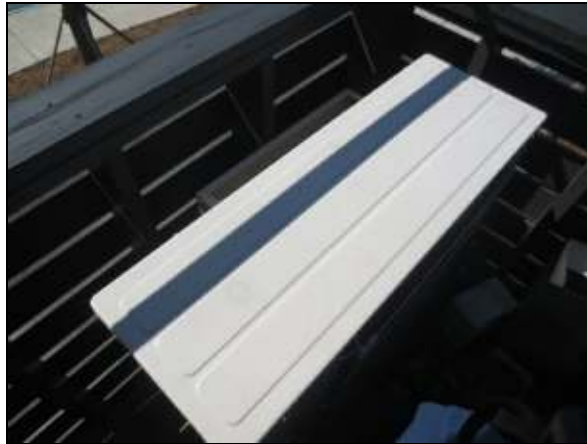
Comp #: 2522 HVAC - Replace

Useful Life:
15 years

Remaining Life:
11 years

We recommend that routine repairs and maintenance such as filter replacements, system flushing, etc. be budgeted as an Operating expense. Useful life can often be extended with proactive service and maintenance. Unless otherwise noted, funding for system with same size/capacity as the current system. For split systems, we recommend budgeting to replace the entire system (condensing unit and air handler) together in order to obtain better unit pricing and ensure maximum efficiency, refrigerant compatibility, etc. If additional costs are expected during replacement, such as for system reconfiguration or expansion, ductwork repairs, electrical work, etc. costs should be re-evaluated and adjusted as needed during future Reserve Study updates. Minimal or no subjective/aesthetic value for this component. Useful life is based primarily on normal expectations for service/performance life in this location. Unless otherwise noted, remaining useful life expectancy is based primarily on original installation or last replacement/purchase date, our experience with similar systems/components, and assuming normal amount of usage and good preventive maintenance.

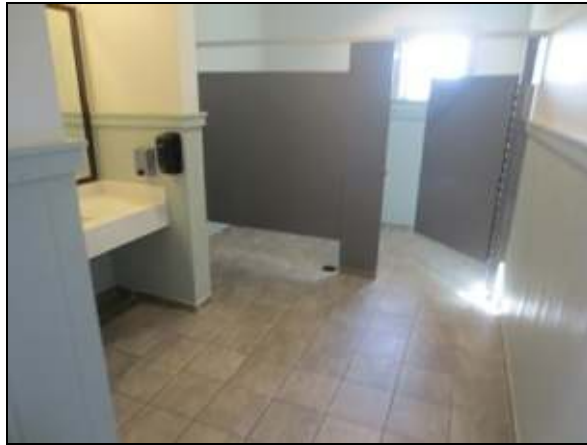
Comments: Bathrooms determined to be in good condition typically exhibit clean, attractive countertops (and cabinetry, if present). Fixtures all appear to be functional and in good aesthetic condition. Flooring and wall finishes show only minor, routine signs of wear and age. Overall, appearance and design aesthetic is good and appropriate for the standards of the community. As routine maintenance, inspect regularly and perform any needed repairs promptly utilizing general Operating funds. Typical remodeling project can include some or all of the following: replacement of plumbing fixtures, partitions, countertops, lighting, flooring, ventilation fans, accessories, décor, etc. Costs can vary greatly depending on scope of work involved. Unless otherwise noted, estimates shown are based primarily on light to moderate cosmetic remodeling, not complete "gut" remodel projects.

Useful Life:
20 years

Remaining Life:
16 years

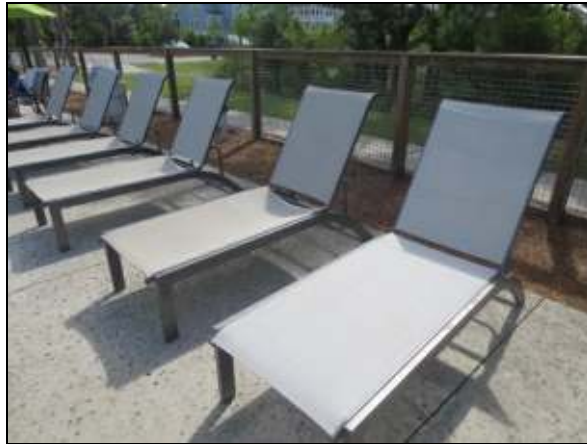
Comp #: 2763 Pool Deck Furniture - Replace

Good condition: Pool deck furniture determined to be in good condition typically exhibits minimal or no signs of aging, such as surface wear, chipped or rusted framework, etc. Pieces are consistent in style and condition and appropriate for the standards of the property.

Useful Life:
10 years

Remaining Life:
6 years

We recommend regular inspections and repair or replacement of any damaged pieces promptly to ensure safety. Protected storage of furniture when not in use can help to extend useful life. Best practice is to replace all pieces together in order to maintain consistent style and quality in the pool/recreation area. Individual pieces can be replaced as needed each year as an Operating expense. Costs can vary greatly based on quantity and type of pieces selected for replacement. Funding recommendation shown here is based on replacement with a comparable number and quality of pieces.

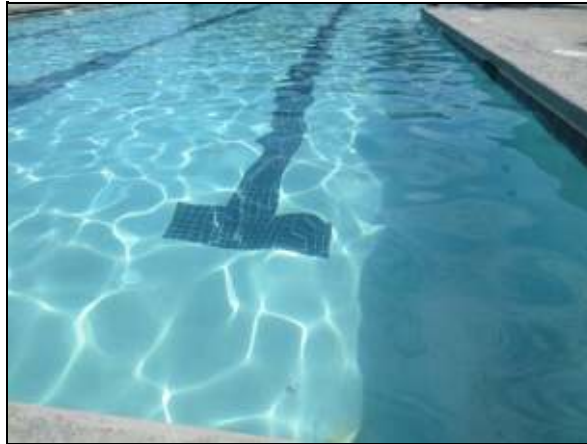
Good condition: Swimming pools determined to be in good condition typically exhibit a generally smooth, consistent appearance with no noticeable chipping or cracking of the surface. Little or no staining or discoloration. Waterline tile/finish is clean and attractive with no cracked or missing tiles.

Useful Life:
12 years

Remaining Life:
8 years

Pool resurfacing will restore the aesthetic quality of the pool while protecting the actual concrete shell of the pool from deterioration. While drained for resurfacing, any other repairs to lighting, handrails, stairs, ladders, etc. should be conducted as needed. This type of project is best suited for slow/offseason to minimize downtime during periods when pool is used heavily. Should be expected at the approximate interval shown below; in some cases, schedule may need to be accelerated due to improper chemical balances or aesthetic preferences of the Client.

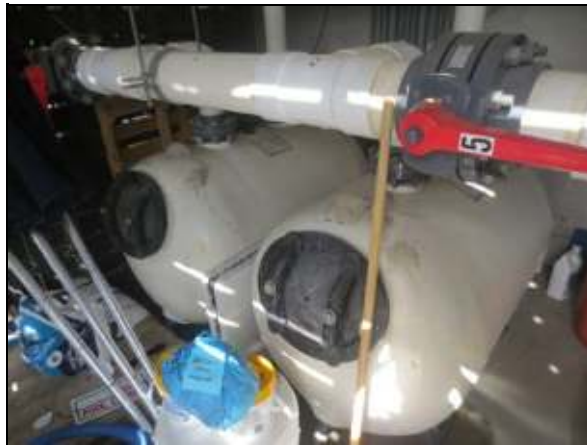
Comp #: 2779 Pool Filters - Replace

Useful Life:
20 years

Remaining Life:
16 years

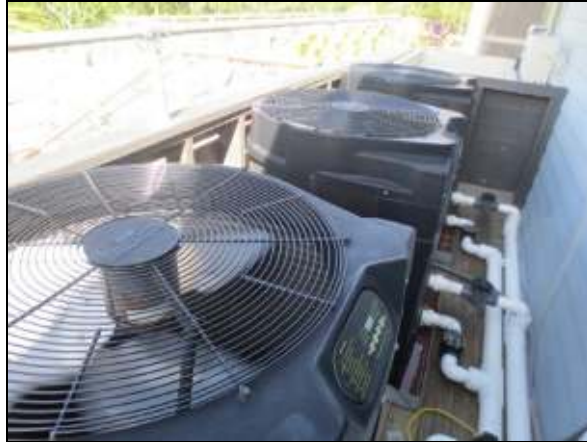
Comp #: 2781 Pool Heaters - Replace

Useful Life:
10 years

Remaining Life:
6 years
