## Update "With-Site-Visit" Reserve Study

**Daniel Island POA  
DICA  
Daniel Island, SC**

**Report #: 15074-5  
For Period Beginning: January 1, 2021  
Expires: December 31, 2021**

**Date Prepared: September 28, 2020**

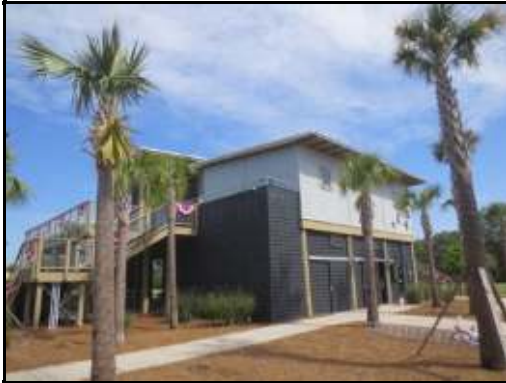
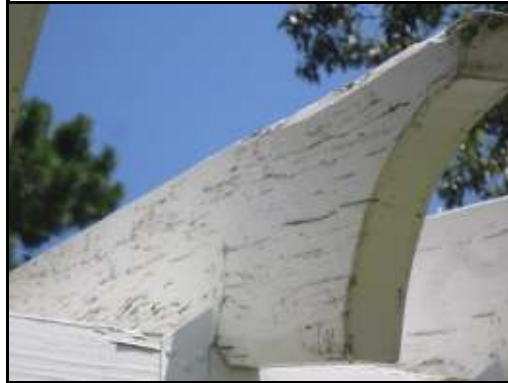
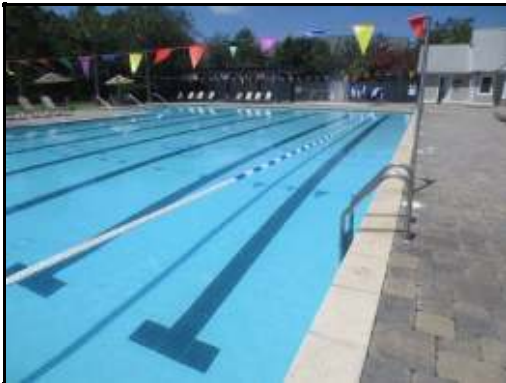
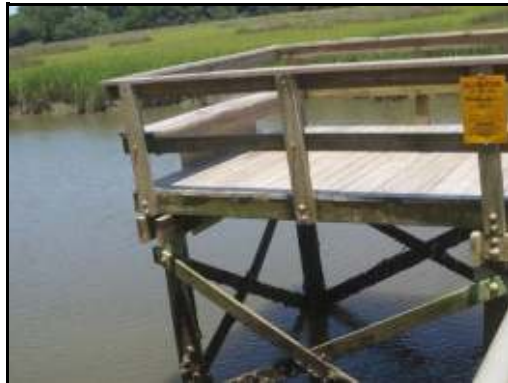
During our site visit on 6/30/2020, we visually inspected all the buildings and were able to see most components up close. The roofs were viewed from the ground but overall most appear to be aging normally. There was some surface wear noticed of the pergolas at each pool. They should be re-painted to help maintain the appearance that is common throughout the community.

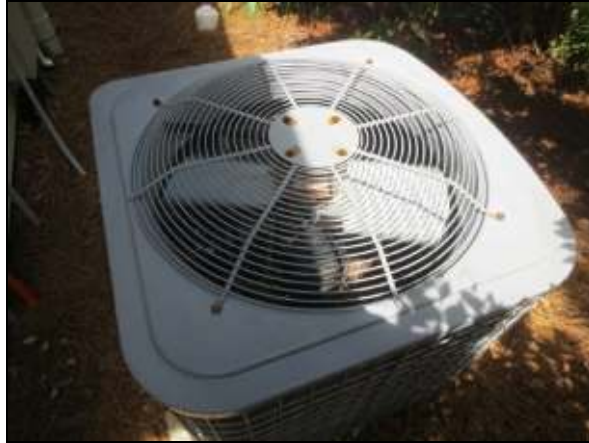
**Comp #: 2519 HVAC Systems (Picnic) - Replace**

History: Replaced in 2015 for \$8,435 according to information provided

Comments: One unit is a 2.5 nominal ton unit with model number N4H330AKF200 and serial number E145001626. the second unit is a 2 nominal ton unit with model number E071127820 and serial number N4H324AKA100. expectancy of HVAC systems can vary greatly depending on location of the property. As routine maintenance, regular professional inspections and maintenance will help to extend useful life cycles. Treat routine repairs/maintenance such as filter replacement as an Operating expense. Plan for replacement at the typical service life expectancy indicated below. With proactive service and maintenance, useful life can often be extended - have service vendor evaluate continuously and adjust useful life / remaining useful life as indicated within Reserve Study updates. Unless otherwise noted, funding for system with same size/capacity as the current system.

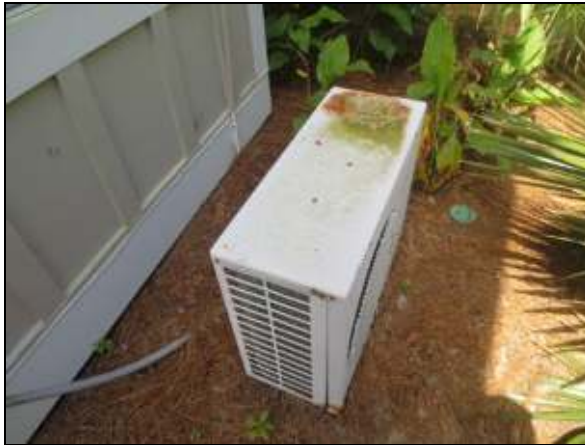
**Comp #: 2519 HVAC Systems (Pool) - Replace**

Life expectancy of HVAC systems can vary greatly depending on location of the property. As routine maintenance, regular professional inspections and maintenance will help to extend useful life cycles. Treat routine repairs/maintenance such as filter replacement as an Operating expense. Plan for replacement at the typical service life expectancy indicated below. With proactive service and maintenance, useful life can often be extended - have service vendor evaluate continuously and adjust useful life / remaining useful life as indicated within Reserve Study updates. Unless otherwise noted, funding for system with same size/capacity as the current system.

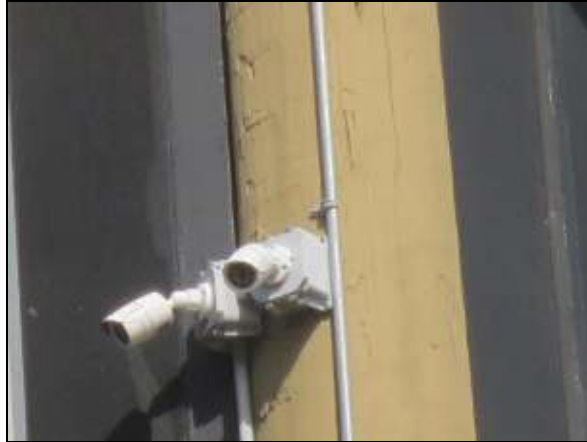
**Comp #: 2543 Security Cameras/Rfid - Replace**

Comments: Security/surveillance systems should be monitored closely to ensure proper function. Whenever possible, camera locations should be protected and isolated to prevent tampering and/or theft. Typical modernization projects may include addition and/or replacement of cameras, recording equipment, monitors, software, etc. Unless otherwise noted, costs assume that existing wiring can be re-used and only the actual cameras and other equipment will be replaced. In many cases, replacement or modernization is warranted due to advancement in technology, not necessarily due to functional failure of the existing system. Keep track of any partial replacements and include cost history during future Reserve Study updates. Minimal or no subjective/aesthetic value for this component. Useful life is based primarily on normal expectations for service/performance life in this location. Unless otherwise noted, remaining useful life expectancy is based primarily on original installation or last replacement/purchase date, our experience with similar systems/components, and assuming normal amount of usage and good preventive maintenance.

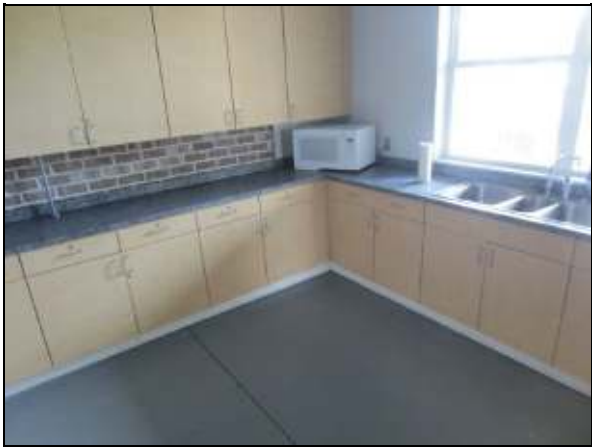
History: \$370 spent on remodeling/repairs in 2015 according to information provided

Comments: The kitchen was in fair condition but had a lower aesthetic quality when compared to the rest of the Pierce Park area. Some of the cabinet handles were broken and should be repaired. The ground was a coated concrete that should have a long useful life. Kitchen materials typically have an extended useful life. However, many associations choose to refurbish the kitchen periodically for aesthetic updating. This may include refurbishment/refinishing of kitchen cabinets and countertops, replacement of sinks, installation/replacement of under-cabinet lighting, etc. Should ideally be coordinated with replacement of the kitchen appliances (see component #2749). Best practice is to coordinate this project with other amenity areas, such as bathrooms or other amenity rooms. Schedule and cost estimates should be re-evaluated during future Reserve Study updates and adjusted as needed based on the association's good judgment.

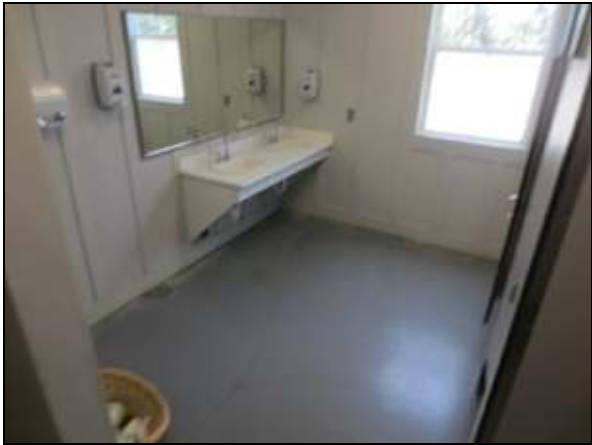
Comments: Bathrooms are in fair condition. RUL has been slightly extended. Concrete floors had some minor chipping. Men's has (2) urinals, (2) toilets and (2) sinks. Women's was locked but is assumed to be more or less the same with no urinals. As routine maintenance, inspect regularly and perform any needed repairs promptly utilizing general Operating funds. Typical remodeling project can include some or all of the following: replacement of plumbing fixtures, partitions, countertops, lighting, flooring, ventilation fans, accessories, décor, etc. Best practice is to coordinate this type of project with other areas whenever possible. Schedule and cost estimates should be re-evaluated during future Reserve Study updates and adjusted as needed based on the association's good judgment.

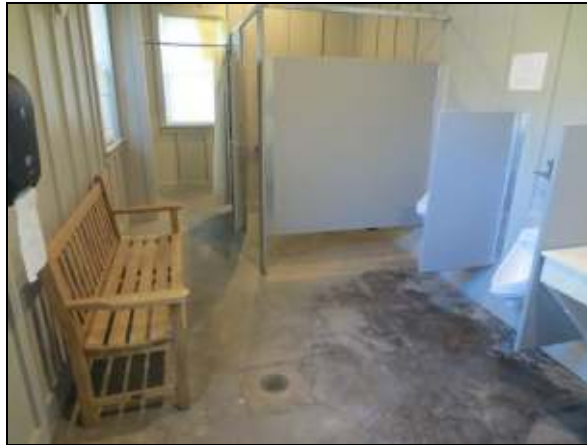
Comments: Bathrooms are in fair condition. RUL has been slightly extended. Men's has (2) sinks, (2) urinals, (1) toilet and (1) shower. Women's is about the same but with (2) toilets. Concrete floors and plain fixtures and finishes.

Fair condition: Bathrooms determined to be in fair condition typically exhibit some light to moderate signs of use and age. Finishes are clean but showing some wear. All fixtures are assumed to be functional, but may be becoming outdated at this stage. Generally in serviceable condition.

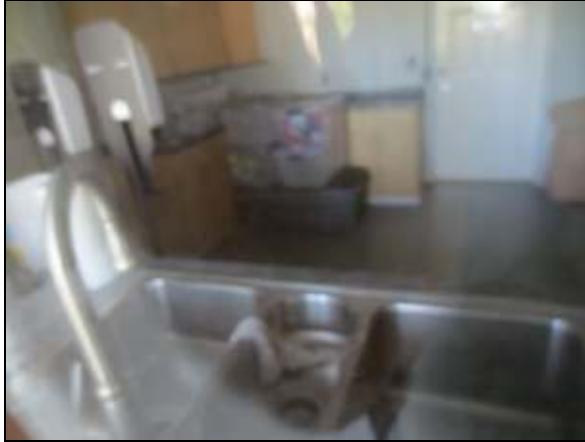
**Comp #: 2749 Kitchen Appliances - Replace**

Comments: Appliances were not tested but assumed to be functioning normally. Equipment had included a microwave, refrigerator/freezer combo and a humidifier. Individual appliances were not tested during inspection, and are assumed to be in functional operating condition unless otherwise noted. Replacement should ideally be coordinated with kitchen remodeling (see component #2747). Funding recommendation shown here is for replacing with comparable quality appliances. Individual pieces may be replaced as needed using Operating funds.

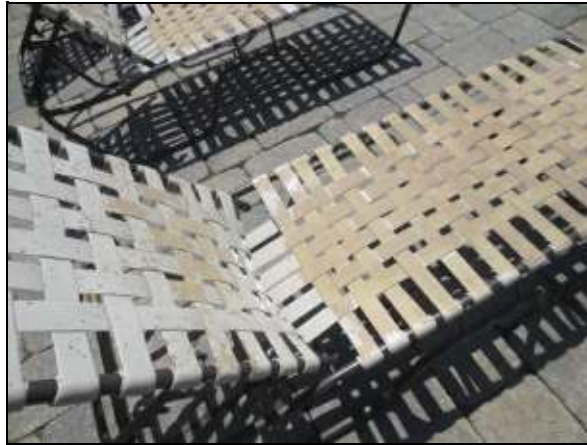
**Comp #: 2763 Pool Deck Furniture - Replace**

History: Some pieces replaced/added in 2017 for \$6,627

Comments: (53) lounges, (14) tables, (67) chairs, (2) benches, (2) trash cans were counted during the inspection. Umbrellas may have been in storage for the season. RUL has been truncated as many of the lounges appear to be aging poorly and have significant surface wear. Could be restrapped.

Inspect regularly and repair or replace any damaged pieces promptly to ensure safety. Protected storage of furniture when not in use can help to extend useful life. Best practice is to replace all pieces together in order to maintain consistent style and quality in the pool/recreation area. Costs can vary greatly based on type of pieces selected for replacement. Funding recommendation shown here is based on replacement with comparable quality pieces.

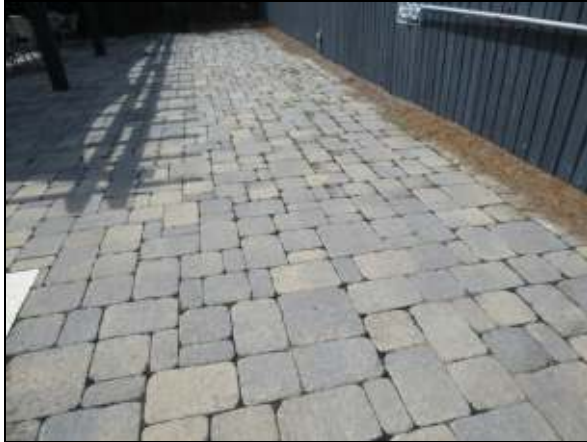
History: Repairs were made in 2016 for \$5,395 according to information provided

Comments: Good condition: Paver pool decks determined to be in good condition typically exhibit an even and positively sloped surface. No obvious trip hazards or significant cracking or damage. Good aesthetic appeal.

Paver decks should have a long useful life under normal circumstances. Should be pressure-washed as needed to preserve appearance and remove stains, chemical residue, etc. Replacement costs can vary depending on style of pavers chosen, configuration of deck, etc. We recommend budgeting for replacement at the approximate interval shown here.

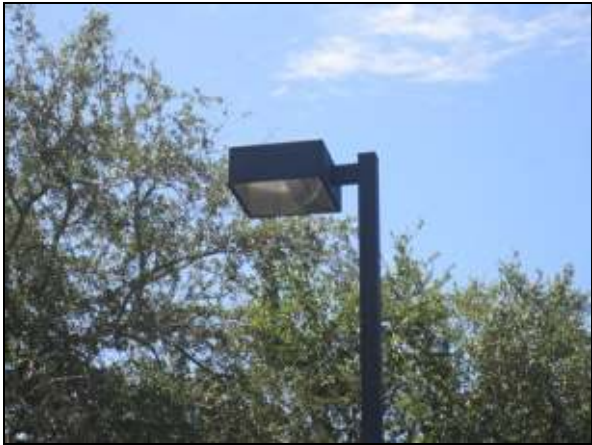
**Comp #: 2772 Pool Deck Lights - Replace**

Comments: (7) single-fixtures, and (3) dual fixtures (as pictured). Fair condition: Pool deck lights determined to be in fair condition typically exhibit somewhat faded/worn appearance but overall assembly is sturdy and aging normally. Serviceable physical condition and still appropriate for aesthetic standards.

Lighting around the pool deck should be inspected regularly to ensure adequate brightness at night for safety. Replacement is often coordinated with other exterior or site lighting, or with pool fence or other components in this area. Cost shown are based on replacement with comparable size and design standards.

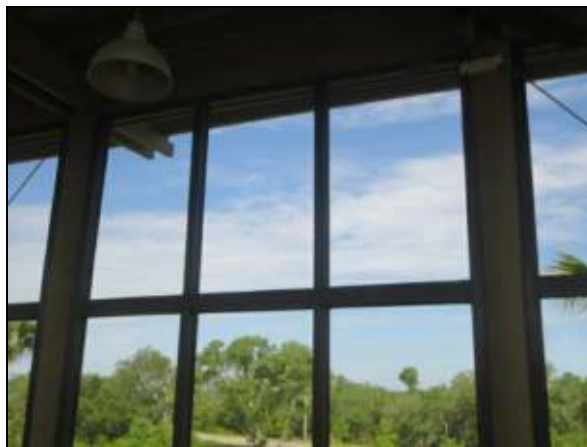
**Comp #: 2344 Building Screening - Replace****Quantity: Approx 2,000 GSF**

Comments: The building screen appeared to be in fair condition. All material was securely fastened to the wooden framing. No tears were visible.

Useful Life:  
10 years

Remaining Life:  
6 years

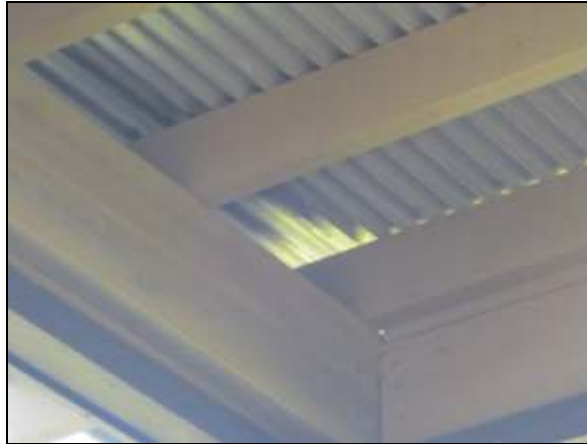
**Comp #: 2384 Metal Roofs - Replace**

Comments: No early signs of rusting or early deterioration. The timeline for metal roof replacement is generally estimated based on the age of the roof. Remaining useful life can also be adjusted based on inspection of any accessible areas, looking for any damaged or lifting sections, signs of advanced corrosion or wear to panels and hardware, as well as consultation with the client about history of repairs and preventive maintenance. Advantages of metal roofs include long life expectancies with relatively low need to repair. Metal roofing is typically a long-lived component assuming it was properly installed and is properly maintained. As routine maintenance, many manufacturers recommend inspections at least twice annually and after large storm events. Promptly replace any damaged/missing sections or conduct any other repair needed to ensure waterproof integrity of roof. We recommend having roof inspected in greater detail (including conditions of sub-surface materials) by an independent roofing consultant prior to replacement. There is a wealth of information available through organizations such as the Roof Consultant Institute <http://www.rci-online.org/> and the National Roofing Contractors Association (NRCA) <http://www.nrca.net/>. If the roof has a warranty, be sure to review terms and conduct proper inspections/repairs as needed to keep warranty in force.

Useful Life:  
30 years

Remaining Life:  
26 years

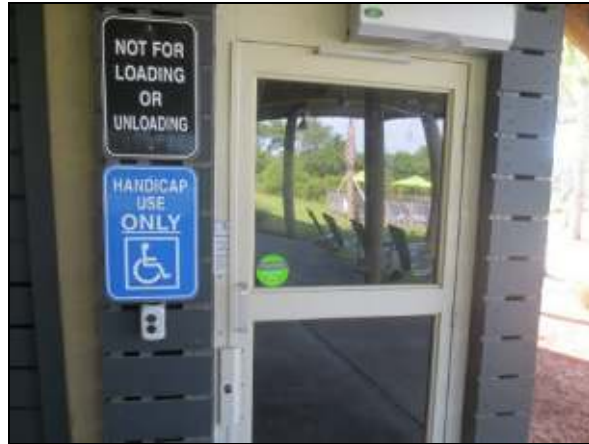
**Comp #: 2518 Wheelchair Lift - Replace**

Useful Life:  
25 years

Remaining Life:  
21 years

Should be inspected for safety and proper function on a regular basis to prevent injury or misuse. Keep moving parts unobstructed and abide by any safety or weight restrictions posted on the device. Vendors report that useful life is not necessarily dependent on level of use, although it is a contributing factor. Replacement is sometimes warranted due to lack of available replacement parts, etc. Minimal or no subjective/aesthetic value for this component. Useful life is based primarily on normal expectations for service/performance life in this location. Unless otherwise noted, remaining useful life expectancy is based primarily on original installation or last replacement/purchase date, our experience with similar systems/components, and assuming normal amount of usage and good preventive maintenance.

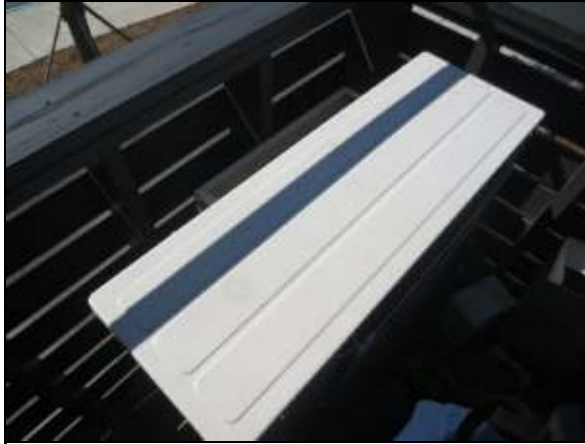
**Comp #: 2522 HVAC - Replace**

Useful Life:  
15 years

Remaining Life:  
11 years

We recommend that routine repairs and maintenance such as filter replacements, system flushing, etc. be budgeted as an Operating expense. Useful life can often be extended with proactive service and maintenance. Unless otherwise noted, funding for system with same size/capacity as the current system. For split systems, we recommend budgeting to replace the entire system (condensing unit and air handler) together in order to obtain better unit pricing and ensure maximum efficiency, refrigerant compatibility, etc. If additional costs are expected during replacement, such as for system reconfiguration or expansion, ductwork repairs, electrical work, etc. costs should be re-evaluated and adjusted as needed during future Reserve Study updates. Minimal or no subjective/aesthetic value for this component. Useful life is based primarily on normal expectations for service/performance life in this location. Unless otherwise noted, remaining useful life expectancy is based primarily on original installation or last replacement/purchase date, our experience with similar systems/components, and assuming normal amount of usage and good preventive maintenance.

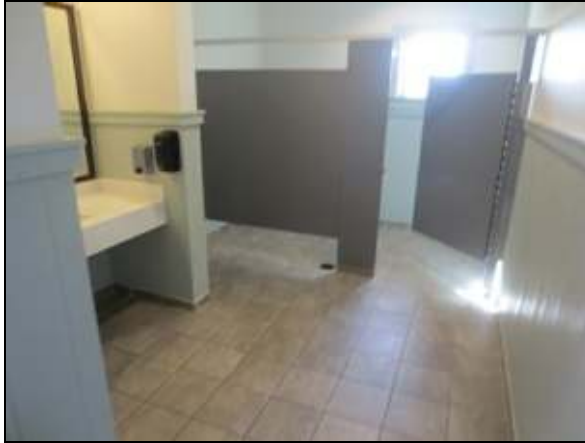
Comments: Bathrooms determined to be in good condition typically exhibit clean, attractive countertops (and cabinetry, if present). Fixtures all appear to be functional and in good aesthetic condition. Flooring and wall finishes show only minor, routine signs of wear and age. Overall, appearance and design aesthetic is good and appropriate for the standards of the community. As routine maintenance, inspect regularly and perform any needed repairs promptly utilizing general Operating funds. Typical remodeling project can include some or all of the following: replacement of plumbing fixtures, partitions, countertops, lighting, flooring, ventilation fans, accessories, décor, etc. Costs can vary greatly depending on scope of work involved. Unless otherwise noted, estimates shown are based primarily on light to moderate cosmetic remodeling, not complete "gut" remodel projects.

Useful Life:  
20 years

Remaining Life:  
16 years

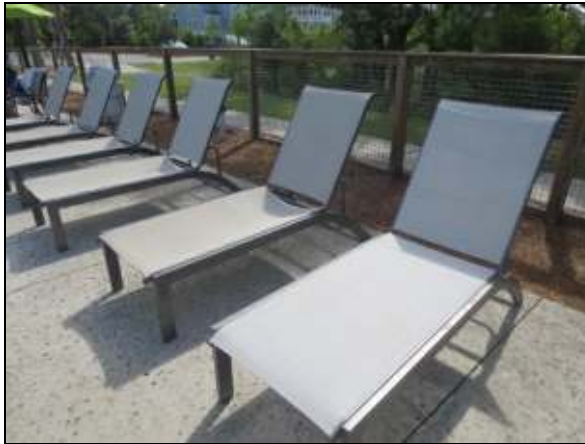
**Comp #: 2763 Pool Deck Furniture - Replace**

Good condition: Pool deck furniture determined to be in good condition typically exhibits minimal or no signs of aging, such as surface wear, chipped or rusted framework, etc. Pieces are consistent in style and condition and appropriate for the standards of the property.

Useful Life:  
10 years

Remaining Life:  
6 years

We recommend regular inspections and repair or replacement of any damaged pieces promptly to ensure safety. Protected storage of furniture when not in use can help to extend useful life. Best practice is to replace all pieces together in order to maintain consistent style and quality in the pool/recreation area. Individual pieces can be replaced as needed each year as an Operating expense. Costs can vary greatly based on quantity and type of pieces selected for replacement. Funding recommendation shown here is based on replacement with a comparable number and quality of pieces.

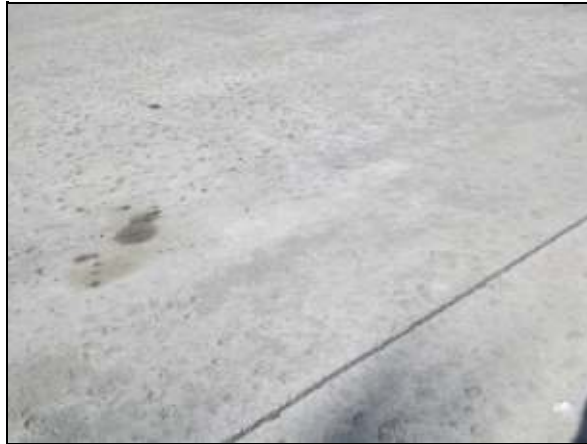
**Comp #: 2767 Pool Deck - Repair****Quantity: Approx 7,030 GSF**

Comments: Concrete deck, which appeared to be in new/good condition at time of inspection.

In general, costs related to this component are expected to be included in the Client's Operating budget. No recommendation for Reserve funding at this time. However, any repair and maintenance or other related expenditures should be tracked, and this component should be re-evaluated during future Reserve Study updates based on most recent information and data available at that time. If deemed appropriate for Reserve funding, component can be included in the funding plan at that time.

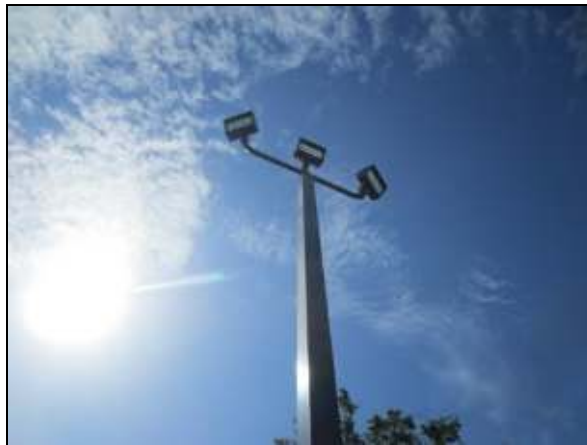
**Comp #: 2772 Pool Deck Lights - Replace****Quantity: (8) Pole, 16 Fixtures**

Comments: Each pole has 2 or 3 fixtures. Good condition: Pool deck lights determined to be in good condition typically exhibit good surface finishes with only minor, normal signs of wear. Fixtures are intact and clear with no unusual signs of age. Style is consistent and appropriate for local aesthetic standards.

Remaining Life:

21 years

Lighting around the pool deck should be inspected regularly to ensure adequate brightness at night for safety. Replacement is often coordinated with other exterior or site lighting, or with pool fence or other components in this area. Cost shown are based on replacement with comparable size and design standards.

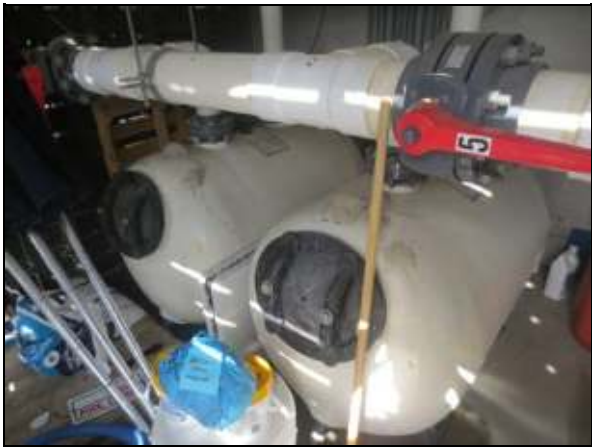
**Comp #: 2779 Pool Filters - Replace**

Useful Life:  
20 years

Remaining Life:  
16 years
