## The Retreat *Daniel Island, SC*

Report #: 53359-0  
Beginning: January 1, 2026  
Expires: December 31, 2026

# RESERVE STUDY "Full"

June 23, 2025

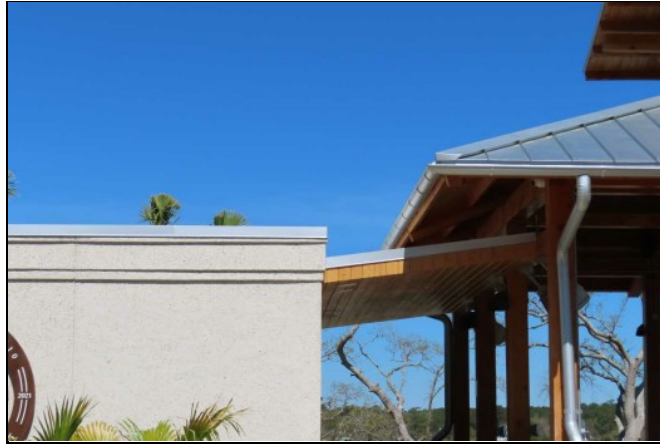
**Comp #: 2389 Gutters/Downspouts - Replace**

**Comments:** Good condition: Gutters and downspouts determined to be in good condition typically exhibit little to no significant surface wear or deterioration of material. No obvious sagging or tilting sections. Attachments to building appear to be strong and stable.

Gutters and downspouts are assumed to be functioning properly unless otherwise noted. As routine maintenance, inspect regularly, keep gutters and downspouts free of debris. If buildings are located near trees, keep trees trimmed back to avoid accumulation of leaves on the roof surface which will accumulate in the gutters and increase maintenance requirements while reducing life expectancy. Repair or replace individual sections as needed as an Operating expense. We generally recommend that the gutters and downspouts be replaced when the roof is being resurfaced/replaced. National Roofing Contractor Association (NRCA) roofing standard includes installing eave flashings at the gutters. We suggest to plan for total replacement of gutter and downspouts at the same intervals as roof replacement for cost efficiency. Unless otherwise noted, costs shown here assume replacement with similar type as are currently in place.

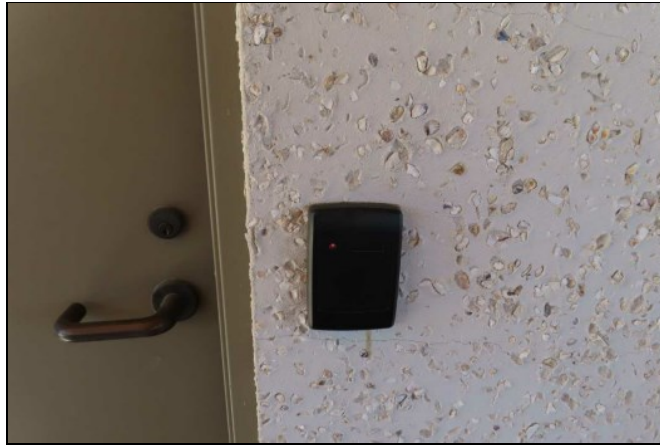
**Comp #: 2503 Access Control System - Replace****Approx Quantity: 4 Readers****Location:** Entrances to building, amenity areas, etc.**Funded?:** Yes. Meets the CAI Reserve Study Standards three-part test.**History:** Presumed to be original to the construction of the community (2024)

**Comments:** Card/fob reader devices are assumed to be functional. Minimal or no subjective/aesthetic value for this component. Individual readers can often be replaced as an Operating expense due to damage or localized failures. Due to use, exposure, and advancements in technology, we recommend to plan for replacement of devices and control system at the approximate interval shown below. To ensure a functional, compatible system and obtain better pricing, plan on replacing all devices together as one project. Any partial repair and/or replacement expenditures should be tracked, and this component should be re-evaluated during future Reserve Study updates based on most recent information and data available.

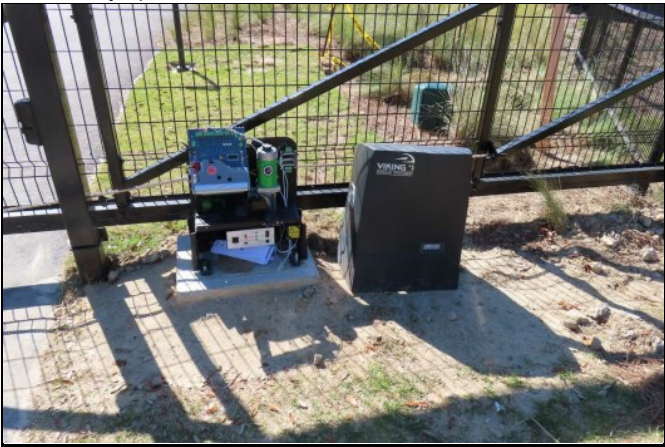
**Comp #: 2509 Gate Operator - Replace**

**Comments:** We recommend regular inspections, including service and repairs as-needed, to be paid through the Operating budget. Minimal or no subjective/aesthetic value for this component. Useful life can vary greatly depending on level of use, exposure to the elements, etc. Even with ongoing maintenance, we recommend that the Client plan for replacement at typical life expectancy indicated below. Remaining useful life expectancy is based primarily on original installation or last replacement/purchase date, our experience with similar systems/components, and assuming normal amount of usage and good preventive maintenance. However, replacement cycles should be tracked and reported by the Client. This component should then be re-evaluated during future Reserve Study updates based on the most current information available at that time.

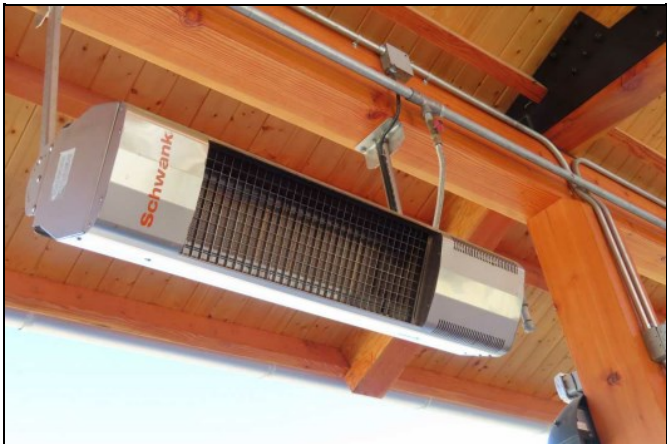
**Comp #: 2522 Overhead Heater (Pavilion) - Replace**

Minimal or no subjective/aesthetic value for this component. Useful life is based primarily on normal expectations for service/performance life in this location. We recommend that routine repairs and maintenance such as filter replacements, system flushing, etc. be budgeted as an Operating expense. Useful life can often be extended with proactive service and maintenance. Remaining useful life expectancy is based primarily on original installation or last replacement/purchase date, our experience with similar systems/components, and assuming normal amount of usage and good preventive maintenance. Funding estimates shown below are for system(s) with same type and size/capacity as the current system. For split systems, we recommend budgeting to replace the entire system (condensing unit and air handler) together in order to obtain better unit pricing and ensure maximum efficiency, refrigerant compatibility, etc. If additional costs are expected during replacement, such as for system reconfiguration or expansion, ductwork repairs, electrical work, etc. costs should be re-evaluated and adjusted as needed during future Reserve Study updates.

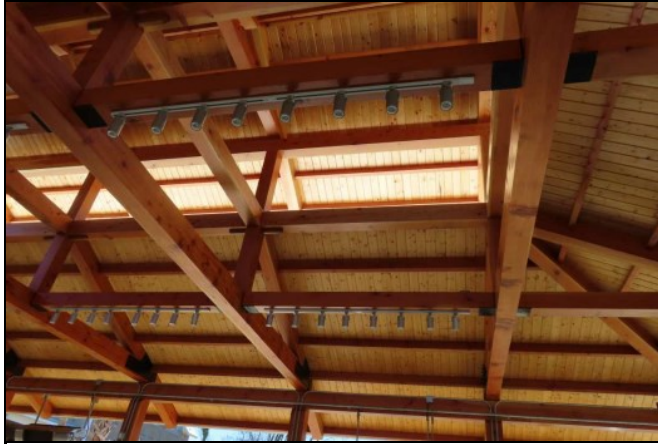
Good condition: Interior lights determined to be in good condition typically exhibit little to no signs of physical wear and tear, and style/fixture type is appropriate for the standards of the property.
